**Transmission and Drivetrain: Technical Service Bulletins**Technical Service Bulletin # **B82871201**Date: **871201****Campaign - Weight Certification Label Are Overstated**

TSB # B821287 December, 1987

SUBJECT: Owner Notification Program B82 - Installation of a Safety Compliance Certification Label on Certain 1988 F250 4x2 HD and F350 4x4 Vehicles Equipped With Optional Engine

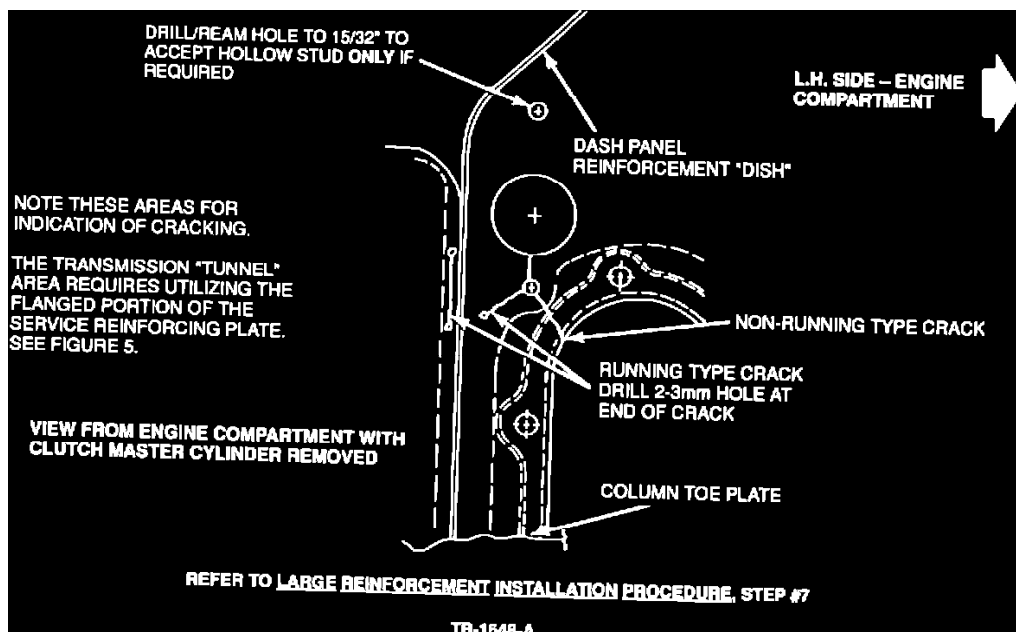
Figure 8

- c. Loosen the two (2) fasteners attaching the brake and clutch pedal support to the Y-brace, Figure 4.
7. Check for cracks.
    - a. Pull back the floor covering and dash sound insulator. (it may be helpful to remove the accelerator pedal.)
    - b. Inspect the area for pulled welds and torn dash sheet metal.

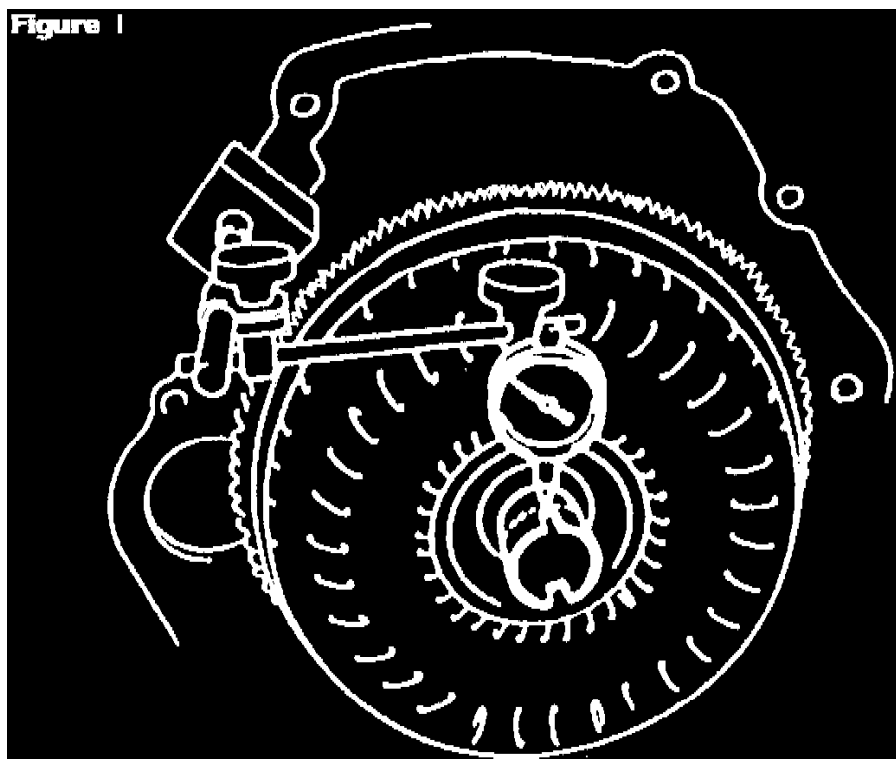
1. Excessive CONVERTER HUB RUN-OUT. This may, or may not be due to a faulty torque converter.

The torque converter can be checked visually, and with a dial indicator. (See Figure 1) Hub run-out should not exceed .010".

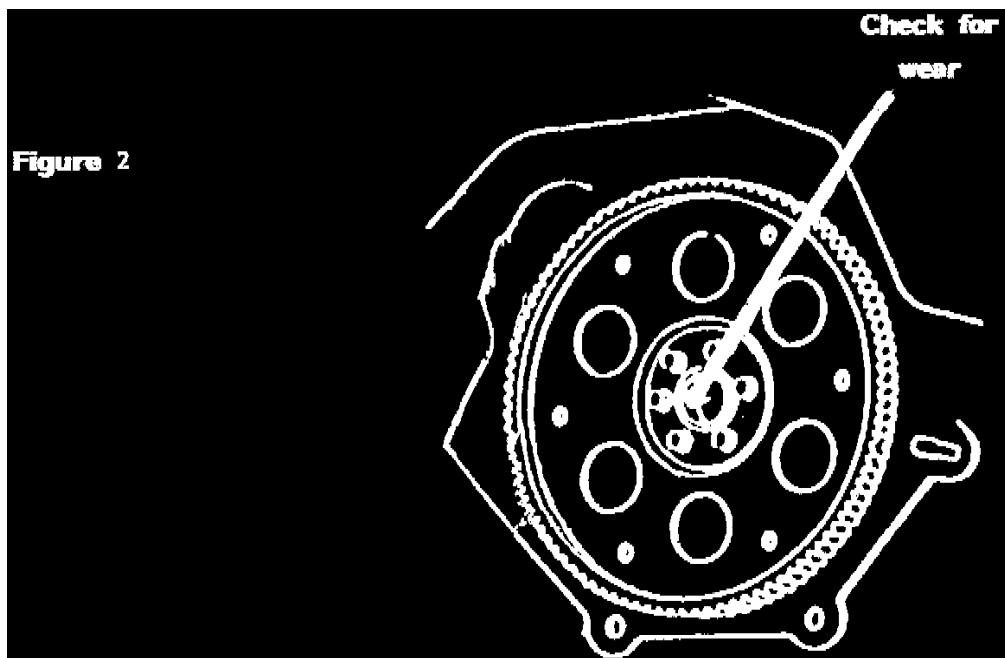
holes can become egg-shaped, or the torque converter pads may wear into the flywheel, causing run-out.

3. Another possibility is WEAR IN THE CRANKSHAFT, where it supports the torque converter pilot.(See Figure 2)

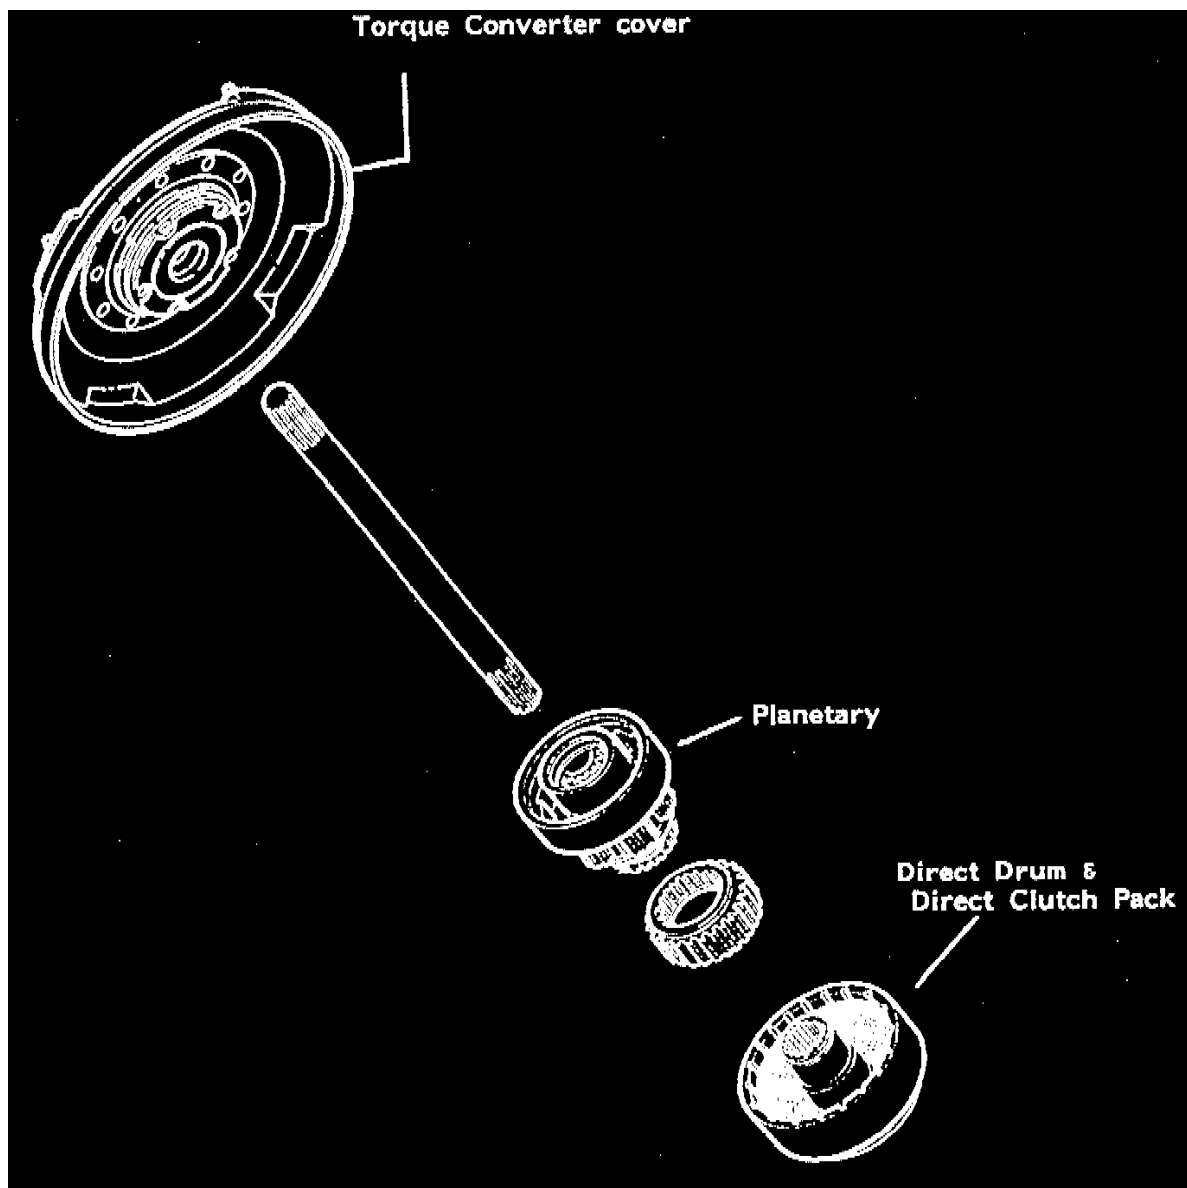
CAUSE: May be direct clutches applied in gear

When applied, the direct clutch pack connects the torque converter to the planetary. If direct clutches are applied when the transmission is shifted into gear, the torque converter will be mechanically connected to the rear wheels.

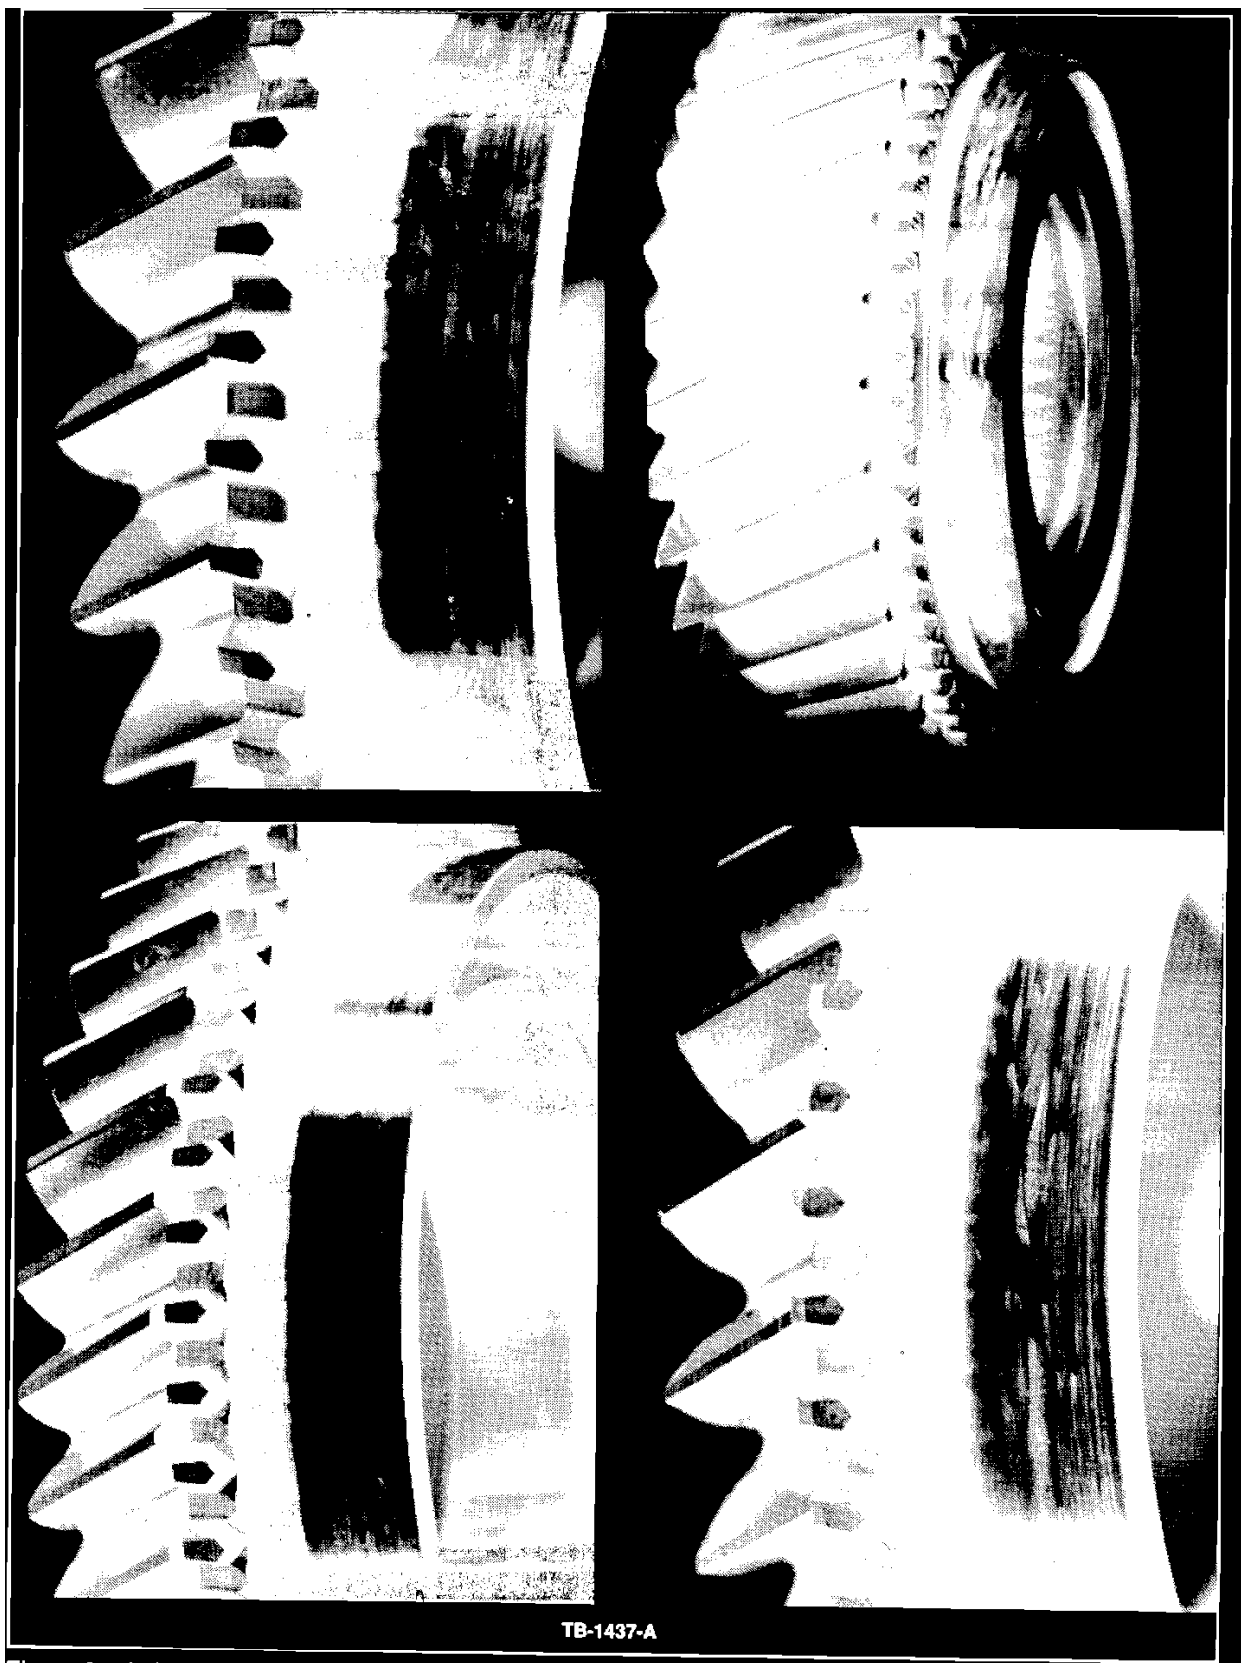
Figure 2

1. Inspect the friction taper cone on the gears and check for the following wear patterns.
  - a. Sporadic slightly burnt patches on otherwise evenly smoothed circumference is acceptable. The patches will appear to be blackish in color and will vary in degree and surface area depending on the synchronizer ring contact area.
  - b. Signs of excessive heat will appear to be burnt to a reddish-blue color, mainly on the edges of the cone. This is a result of excessive overloading, operating failure or perhaps a malfunctioning clutch system.
2. Replace gears showing excessively burnt spots (reddish-blue) on the friction taper cone edges. In this case the selector teeth will be damaged as well. Refer to the appropriate Light Truck Shop Manual, Section 16-34 for service details.
