Ignition Cable: All Technical Service Bulletins Spark Plug Wires - MIL ON/DTCs P0300 Through P0308 Set

Article No.
96-25-23

12/02/96

1997 ECONOLINE, EXPEDITION, F-150

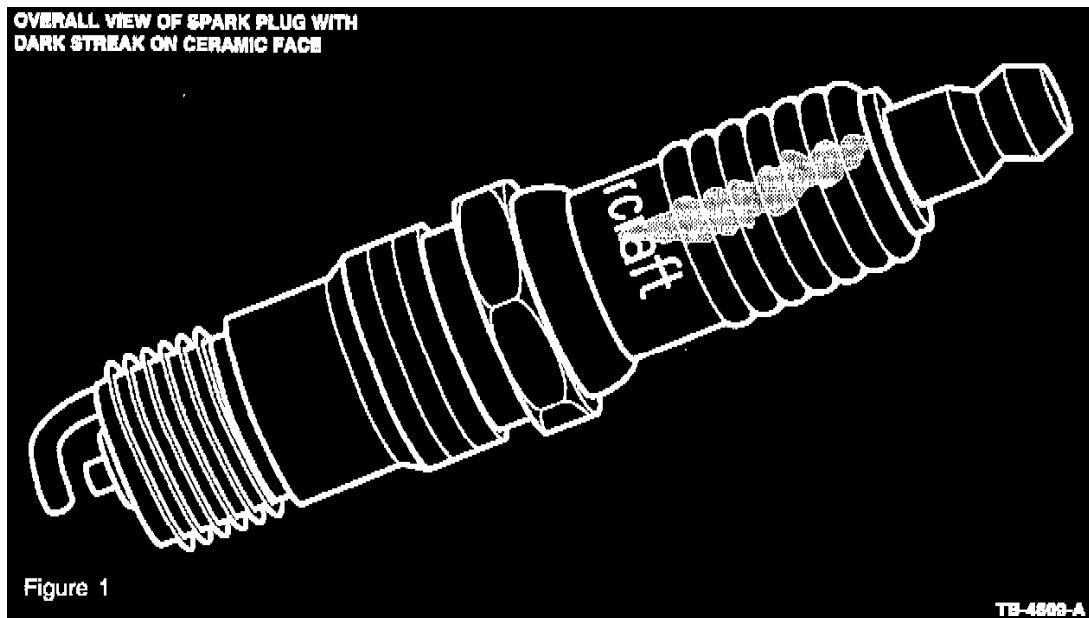
2. Inspect the spark plugs for signs of "tracking." If "tracking" is present, there may be a fine, broken "pencil" line on the blue rings only and/or a thick smudgy series of continuous lines depending on how long the vehicle was operated while misfiring. These lines may feel like a crack if the fingernail is rubbed across the lines. Refer to Figure 1.
3. If "tracking" is found, replace all eight (8) of the spark plugs and torque the new Spark Plugs (AWSF-32-PP) to 16-20 N.m (12-15 lb-ft).
4. Replace all eight (8) of the Spark Plug Wires with new wires (F6PZ-12259-HC). Be sure to apply Silicone Caliper Grease and Dielectric Compound (D7AZ-19A331-A) on the inside of all spark plug wire boots.
