**Transmission and Drivetrain: Technical Service Bulletins**Technical Service Bulletin # **B82871201**Date: **871201****Campaign - Weight Certification Label Are Overstated**

TSB # B821287 December, 1987

SUBJECT: Owner Notification Program B82 - Installation of a Safety Compliance Certification Label on Certain 1988 F250 4x2 HD and F350 4x4 Vehicles Equipped With Optional Engine

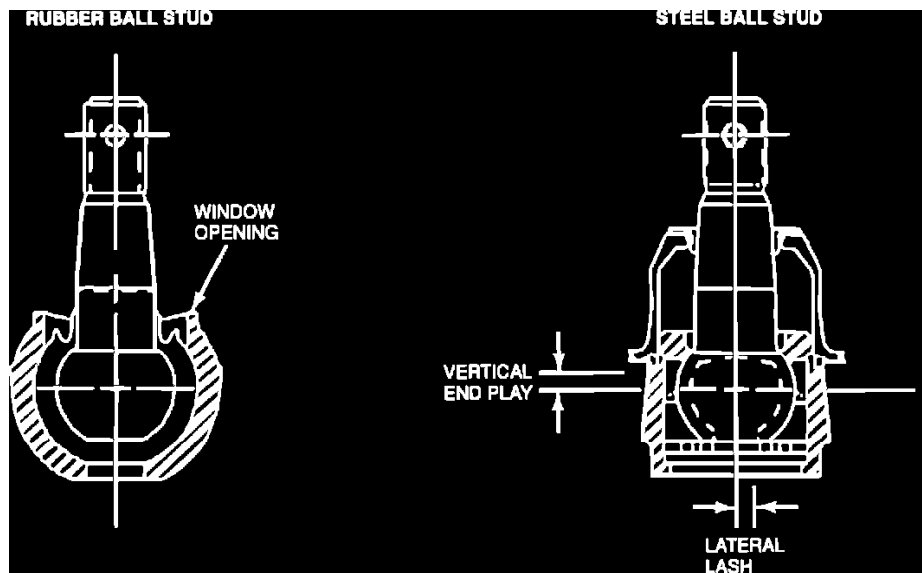
**Figure 1**

1. With the weight on the front wheels, check the linkage joints while someone else turns the steering wheel from side to side.

- a. For rubber ball socket (RBS) joints, see if the ball stud makes contact with the window opening in the socket bowl while on the truck, Figure 1. If contact is made with the window opening, replace it with a greaseable steel joint.
- b. For steel (greaseable) joints, measure the lateral (side to side) lash in the joint, Figure 1.
  1. If the lash exceeds .060" (1.59 mm), replace the joint.
  2. With the truck on a hoist, check the steel (greaseable) joints for vertical (up and down) end play by pushing and pulling on the joint, Figure 1. If the end play exceeds .090" (2.38 mm), replace the joint.

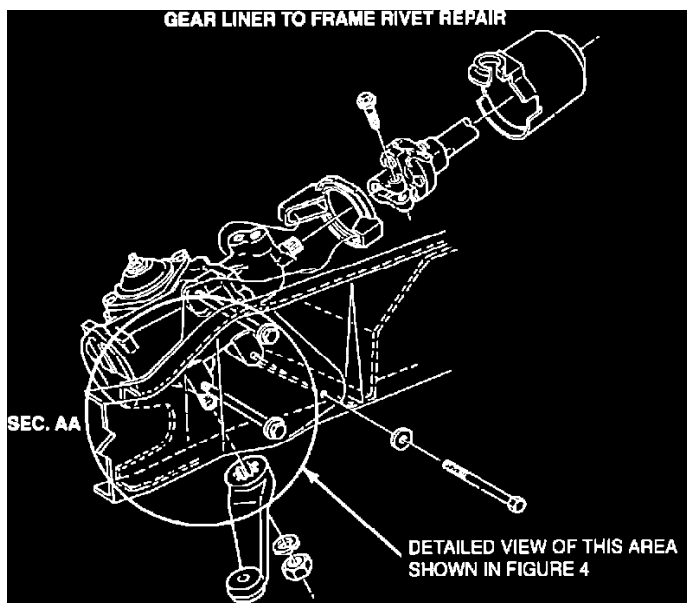
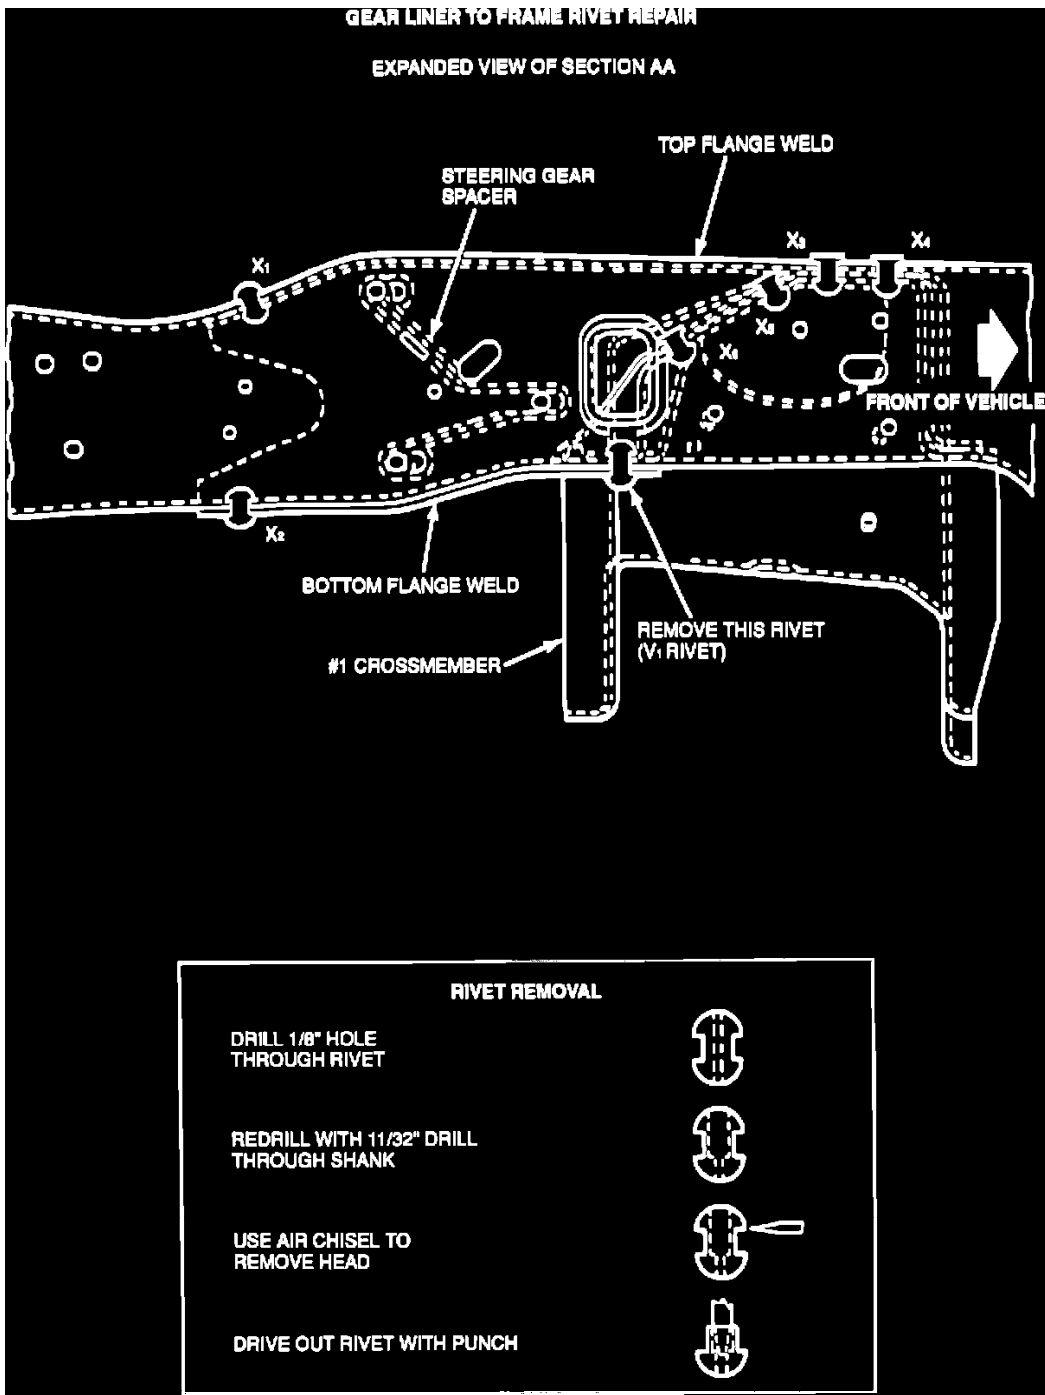
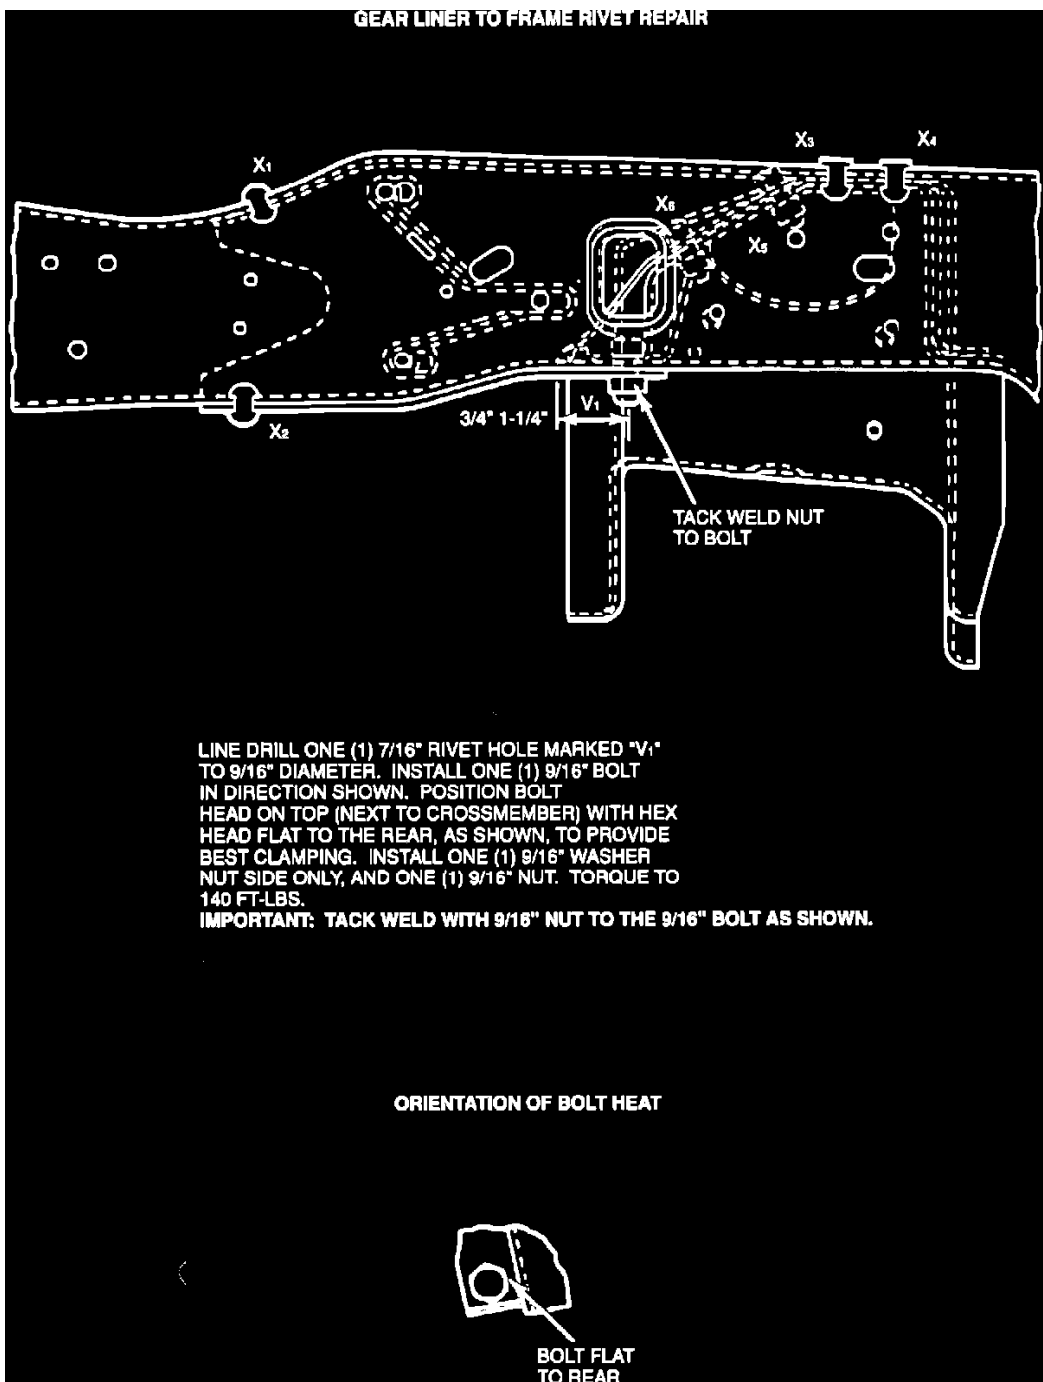
1. Inspect the mounting surface of the steering gear. Check the frame area for the following:
  - ^ Signs of motion
  - ^ Loose rivets
  - ^ Cracks - Removal of the gear from the frame may be required to check for cracks.

LINE DRILL ONE (1) 7/16" RIVET HOLE MARKED "V1" TO 9/16" DIAMETER. INSTALL ONE (1) 9/16" BOLT IN DIRECTION SHOWN. POSITION BOLT HEAD ON TOP (NEXT TO CROSSMEMBER) WITH HEX HEAD FLAT TO THE REAR, AS SHOWN, TO PROVIDE BEST CLAMPING. INSTALL ONE (1) 9/16" WASHER NUT SIDE ONLY, AND ONE (1) 9/16" NUT. TORQUE TO 140 FT-LBS.  
**IMPORTANT: TACK WELD WITH 9/16" NUT TO THE 9/16" BOLT AS SHOWN.**

2. Repair trucks with a cracked frame liner or loose rivets by using Frame Repair Kit (E6TZ-5K130-A). See Figures 3, 4 and 5.
3. Inspect the frame for cracks in the following areas.

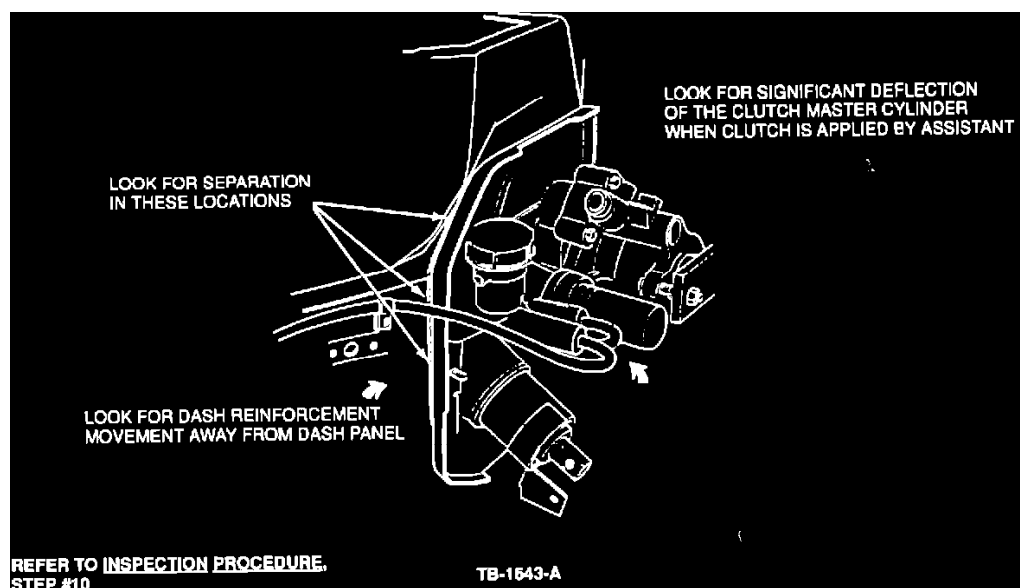
Figure 3

- c. Look for the dash reinforcement moving away from the dash, Figure 3.

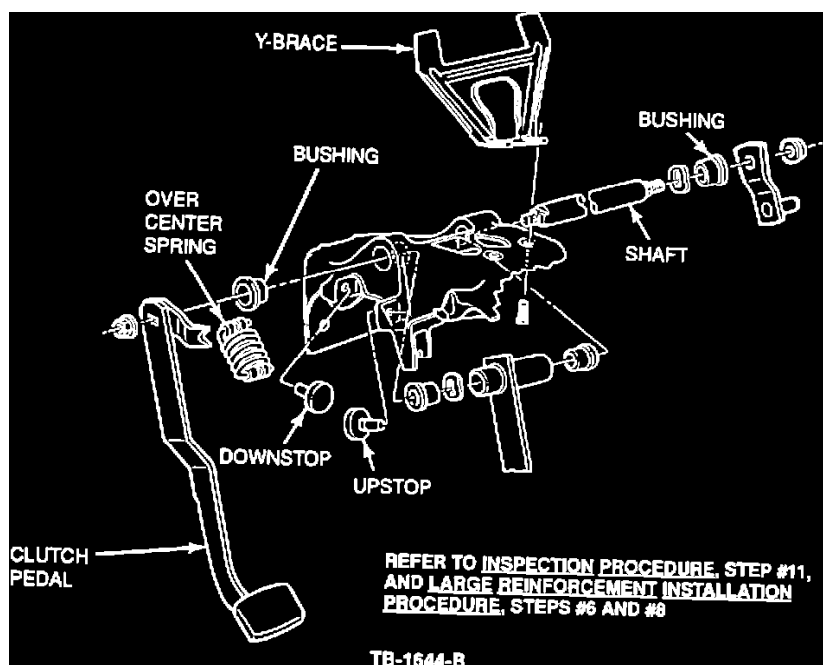
**Figure 4**

- ^ Missing Y-brace fasteners and a broken or detached Y-brace, Figure 4.

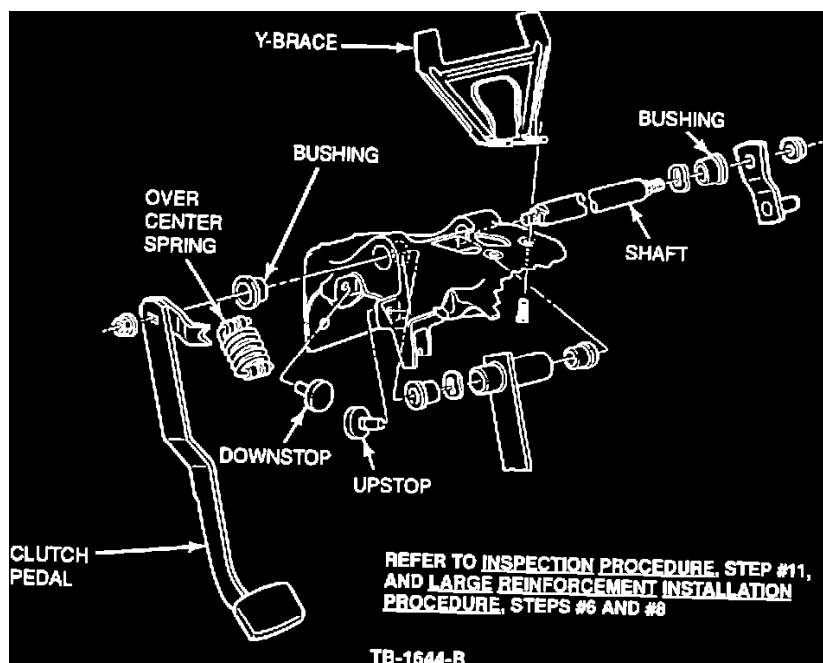
Figure 4

8. Thoroughly inspect the brake and clutch support again for cracks in the casting and worn bushings. Also, inspect the "Y" brace for cracks and missing fasteners. Replace as necessary, Figure 4.
9. Remove excess body sealer in the area of the clutch master cylinder, inside the dash.
10. Carefully remove the cowl top cover 12 fasteners (7 in front, 5 in rear).

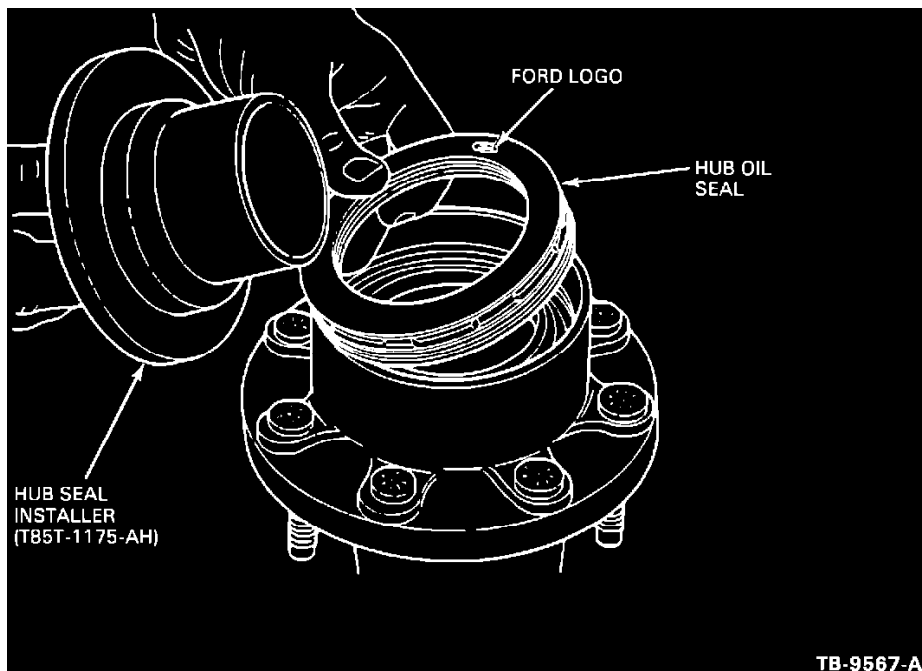
FIGURE 12

ISSUE: Lubricant leaking from the rear axle on F-250 and F-350 trucks, with Ford 10.25" full float axles may be caused by the hub seal. The leaking condition could affect trucks with single or dual rear wheels.

1. Position hub seal with the "Ford" logo facing up, Figure 12.

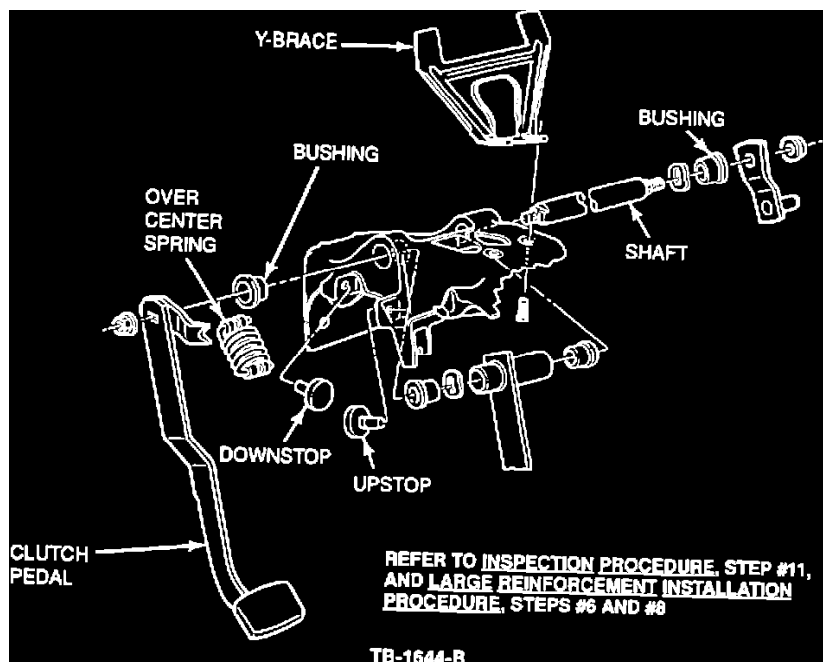
Figure 4

- ^ Missing Y-brace fasteners and a broken or detached Y-brace, Figure 4.

- c. Loosen the two (2) fasteners attaching the brake and clutch pedal support to the Y-brace, Figure 4.
7. Check for cracks.
    - a. Pull back the floor covering and dash sound insulator. (it may be helpful to remove the accelerator pedal.)
    - b. Inspect the area for pulled welds and torn dash sheet metal.

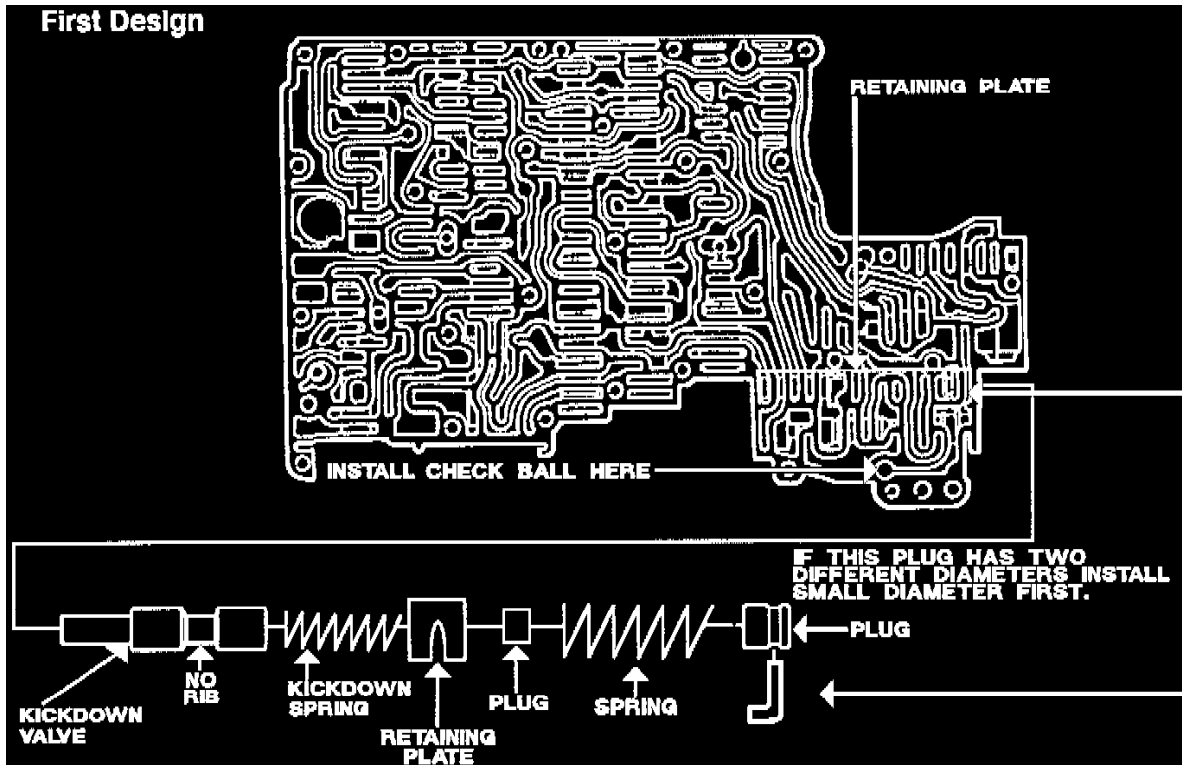
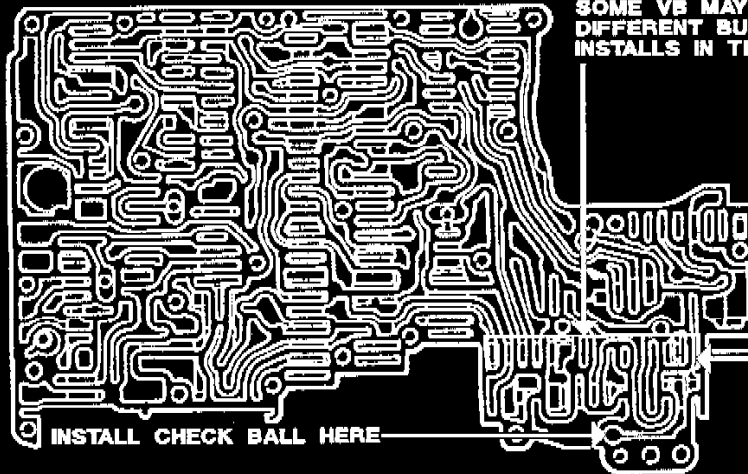
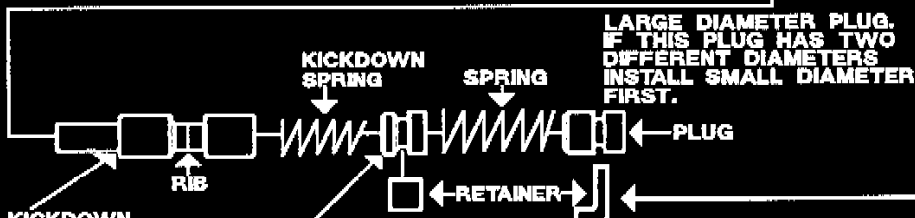
Some A4LD valve body assemblies do not use a check ball to cushion reverse engagement. These valve bodies are equipped with a reverse engagement control valve. Inspect your valve body for the correct assembly using the 3 drawings provided. Do not leave out the check ball on valve bodies that do not have this valve. If the reverse engagement control valve is stuck you may have no reverse.

INSTALL CHECK BALL HERE

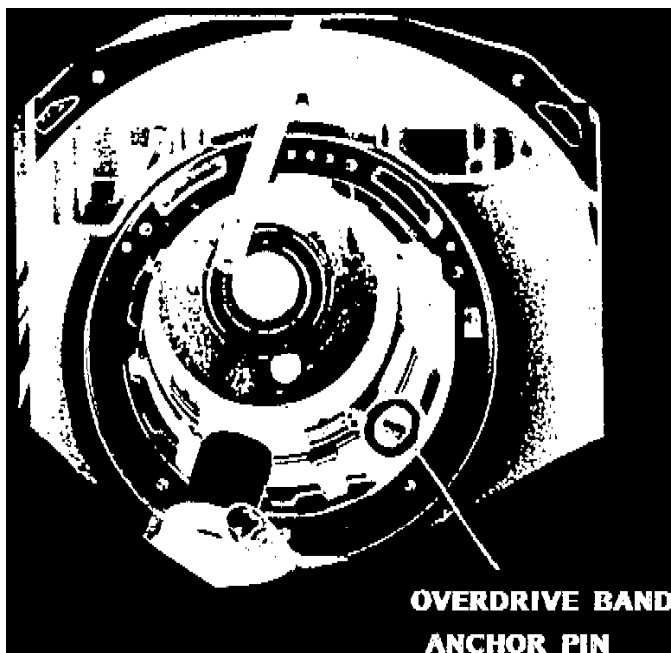
If the problem exists no matter which selective thrust washer is used, it may be the overdrive band anchor pin binding the overdrive band against the reverse clutch drum.

During assembly, it may not appear that the band is binding against the reverse clutch drum. When the pump is installed, it may move the reverse clutch drum to center it, and that's when the reverse clutch drum and the overdrive band will bind.

Knock the overdrive anchor pin outward until it is no longer binding the overdrive band against the reverse clutch drum. Be careful; do not tap the anchor pin out too far! Put sealant on the anchor pin where it extends to the outside of the case.

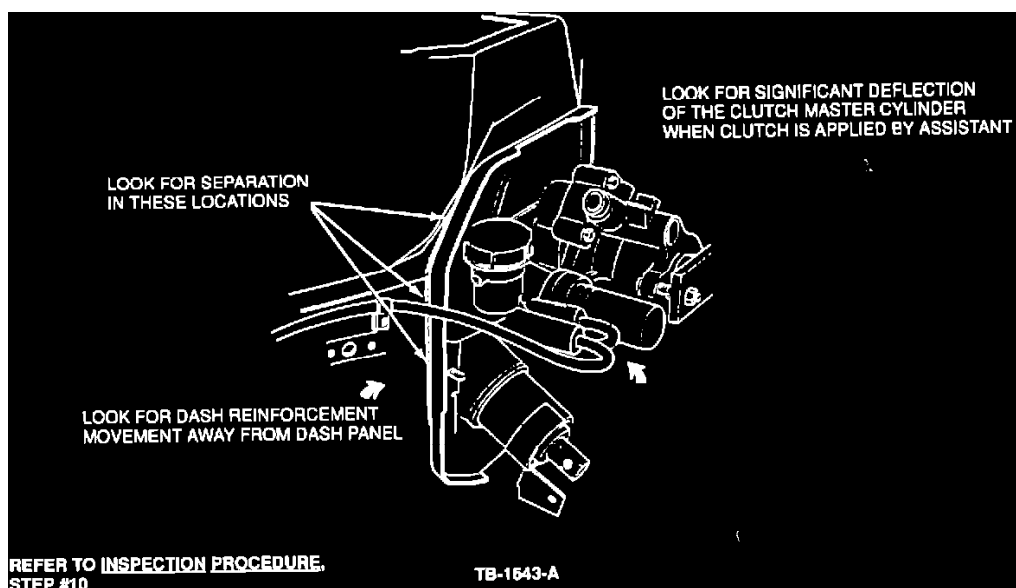
Figure 3

- c. Look for the dash reinforcement moving away from the dash, Figure 3.

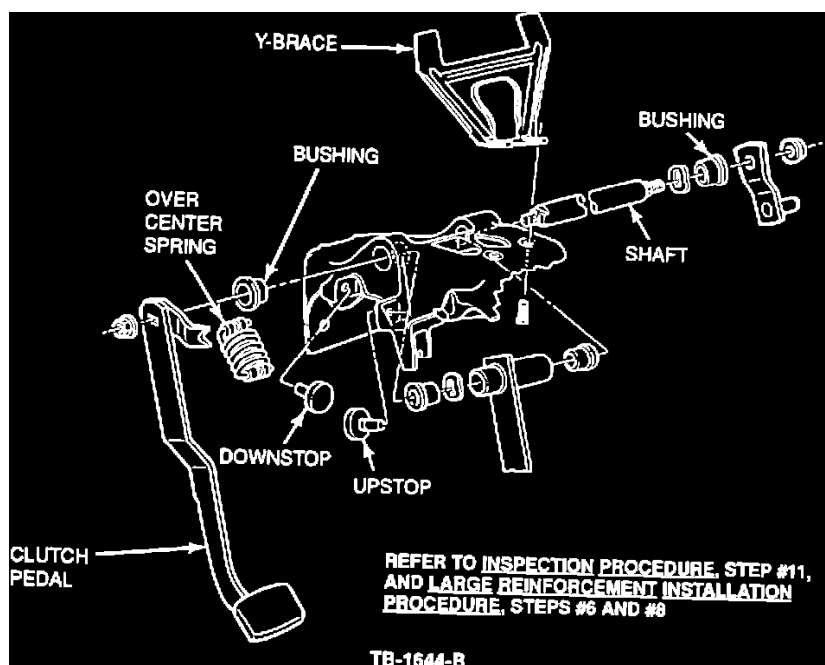
Figure 4

^ Missing Y-brace fasteners and a broken or detached Y-brace, Figure 4.

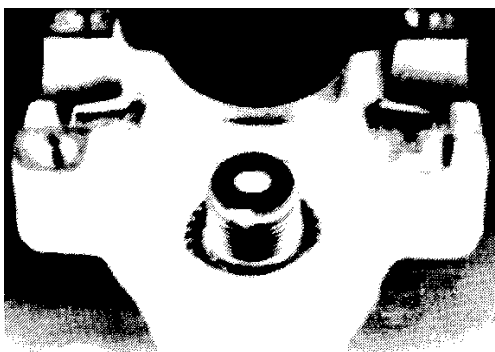
**TB-1555-A****Figure 1**

**ISSUE:** A "bumping/clunking" noise or a "clicking" sound on torque reversal or transmission lubricant leakage may be caused by a loose output flange retaining nut.

1. Install a new output flange retaining nut (E7TZ-7045-A) on the output shaft, Figure 1.

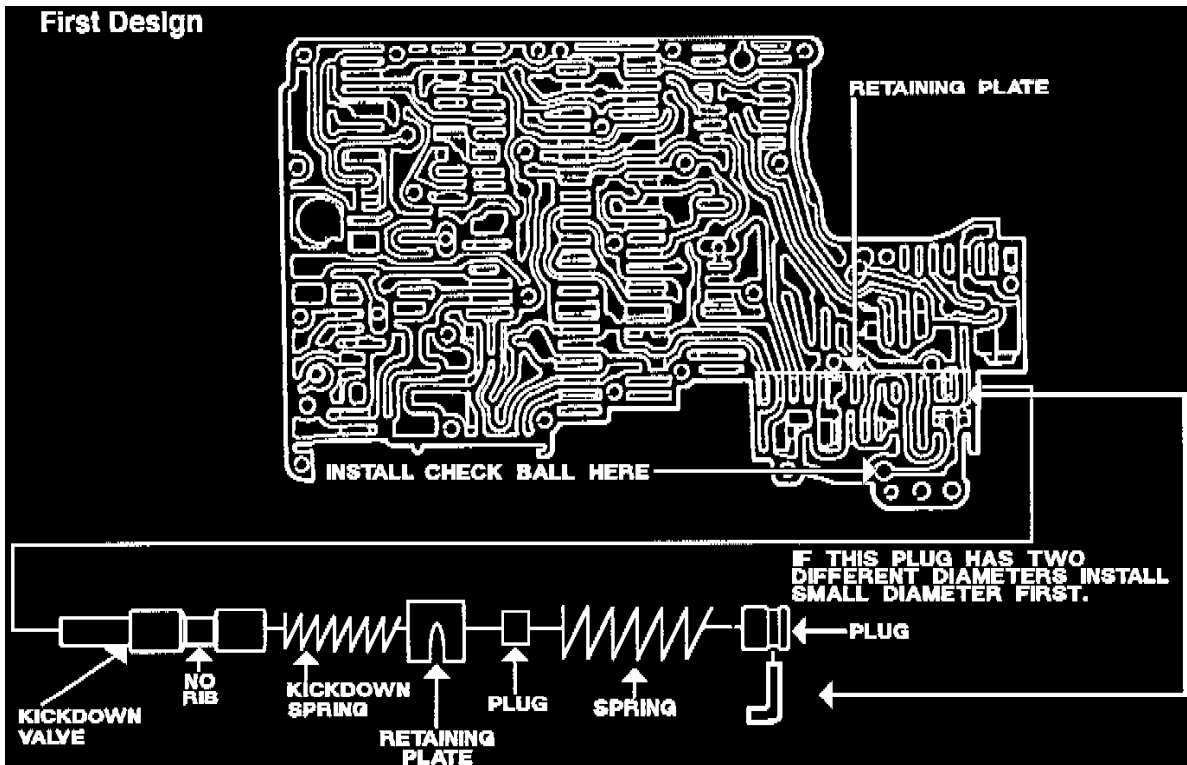
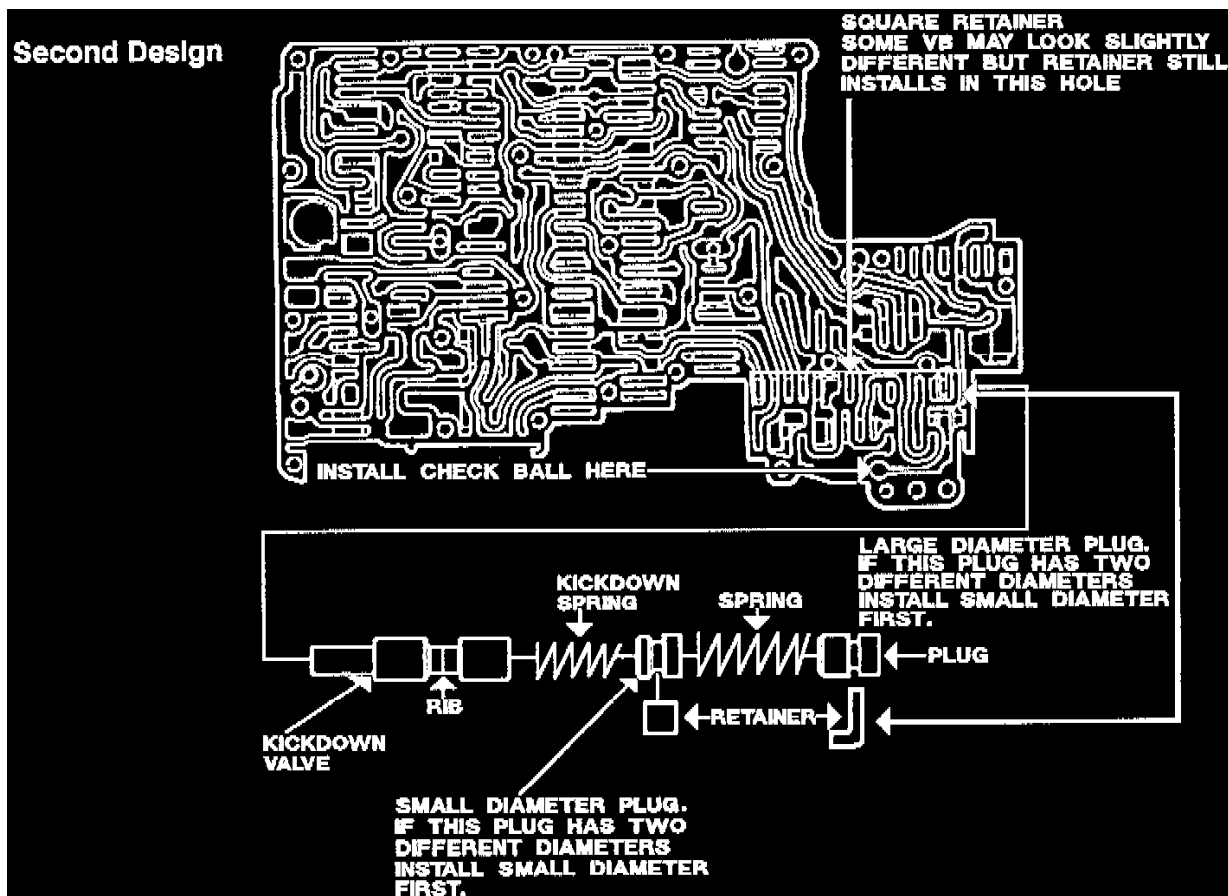
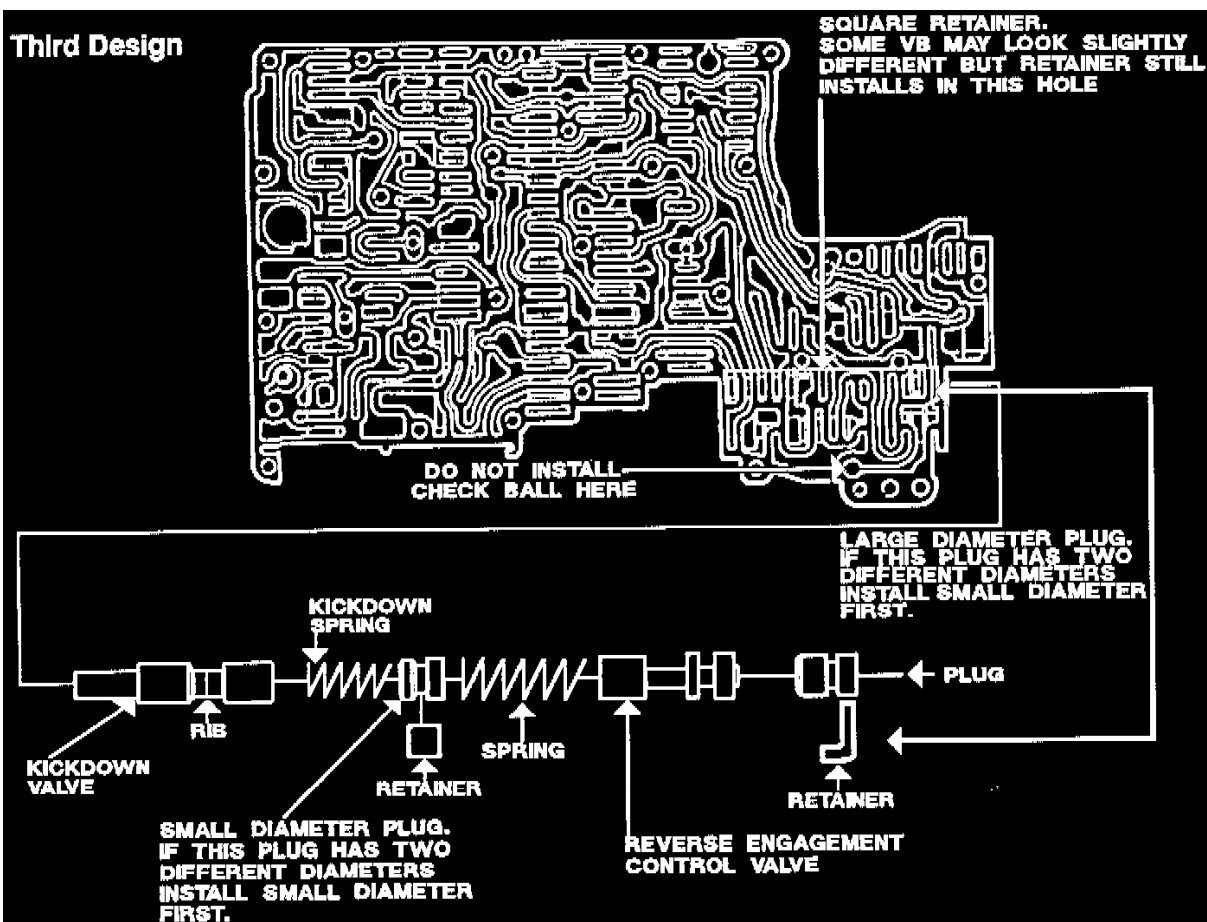
Some A4LD valve body assemblies do not use a check ball to cushion reverse engagement. These valve bodies are equipped with a reverse engagement control valve. Inspect your valve body for the correct assembly using the 3 drawings provided. Do not leave out the check ball on valve bodies that do not have this valve. If the reverse engagement control valve is stuck you may have no reverse.

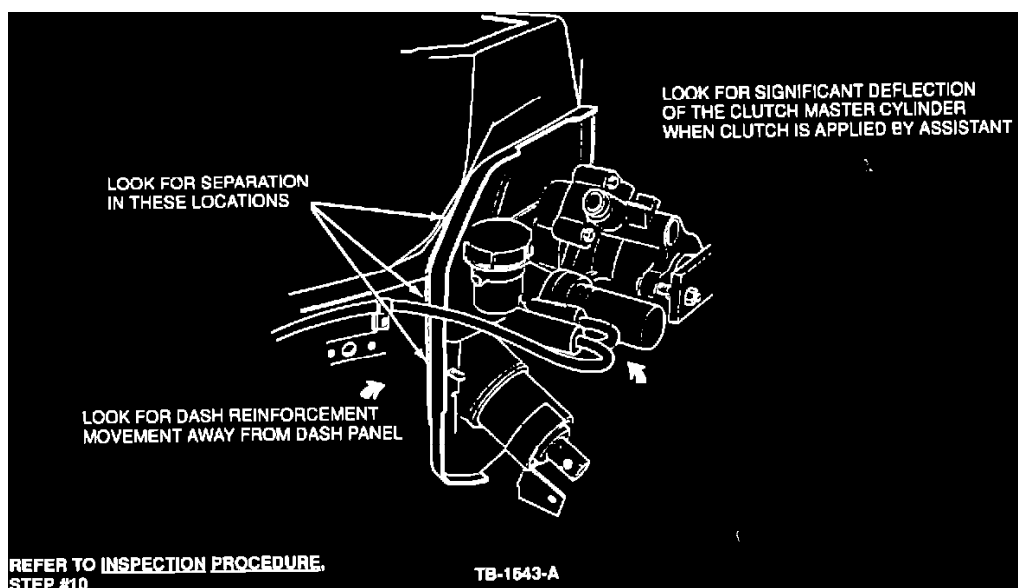
Figure 3

- c. Look for the dash reinforcement moving away from the dash, Figure 3.

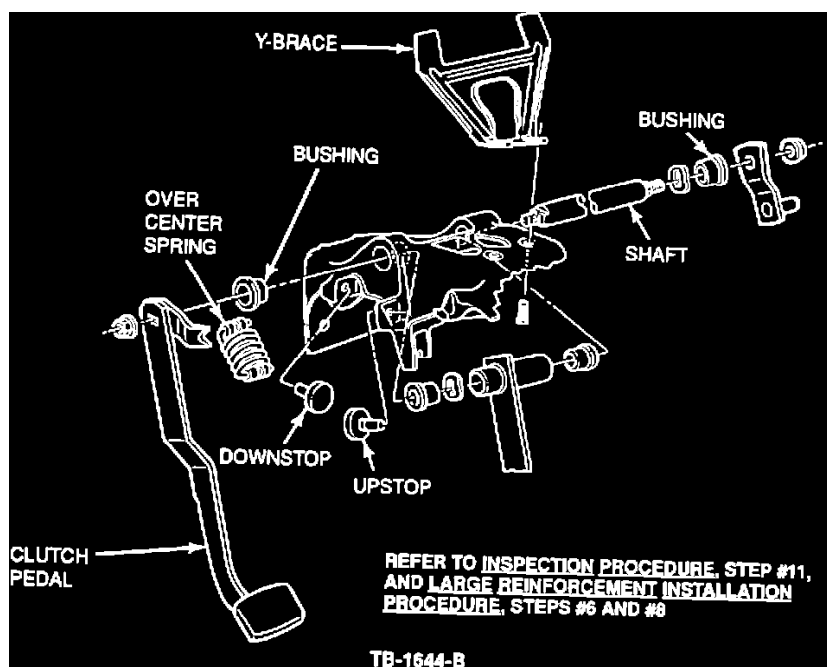
Figure 4

- ^ Missing Y-brace fasteners and a broken or detached Y-brace, Figure 4.

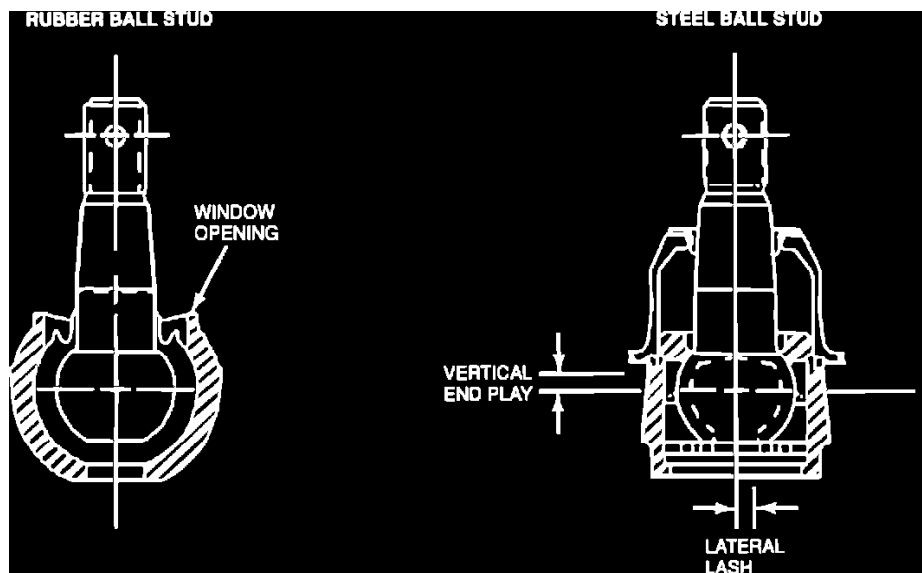
Figure 1

- a. For rubber ball socket (RBS) joints, see if the ball stud makes contact with the window opening in the socket bowl while on the truck, Figure 1. If contact is made with the window opening, replace it with a greaseable steel joint.
- b. For steel (greaseable) joints, measure the lateral (side to side) lash in the joint, Figure 1.
  1. If the lash exceeds .060" (1.59 mm), replace the joint.
  2. With the truck on a hoist, check the steel (greaseable) joints for vertical (up and down) end play by pushing and pulling on the joint, Figure 1. If the end play exceeds .090" (2.38 mm), replace the joint.

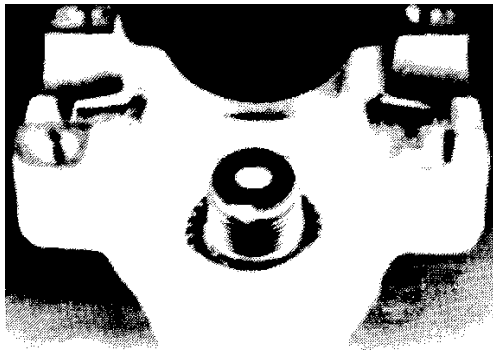
**TB-1555-A****Figure 1**

**ISSUE:** A "bumping/clunking" noise or a "clicking" sound on torque reversal or transmission lubricant leakage may be caused by a loose output flange retaining nut.

1. Install a new output flange retaining nut (E7TZ-7045-A) on the output shaft, Figure 1.

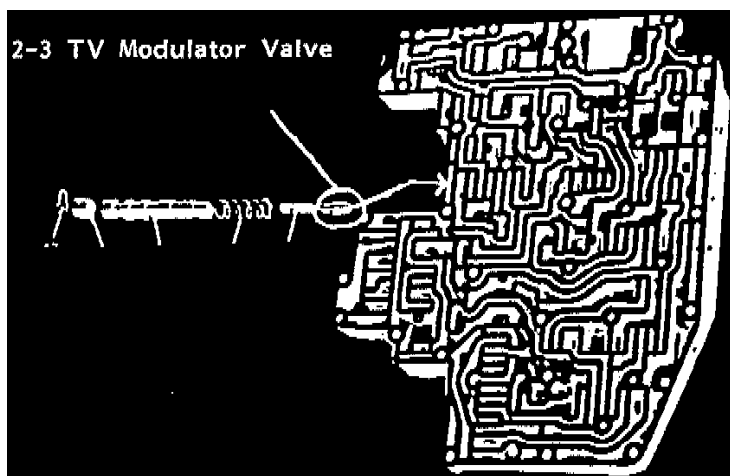
Too sensitive 3-2, or no 3-2 part throttle downshift.

May be a sticky 2-3 TV modulator valve. If it sticks closed, it can cause a no 3-2 part throttle downshift. If valve sticks open, it can cause a too sensitive 3-2 downshift.

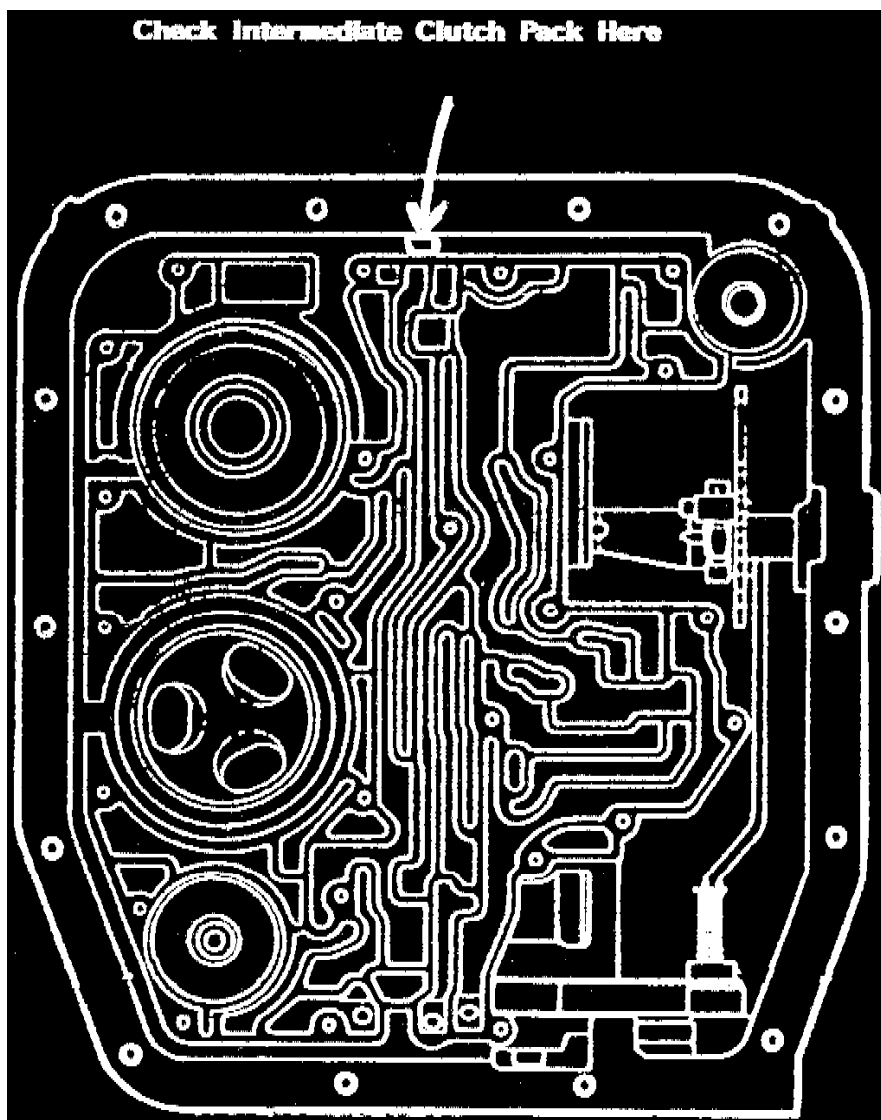
May be caused by improper intermediate clutch pack clearance

If intermediate clutch pack clearance is not checked on AOD transmissions, the intermediate return spring assembly in the pump may drag the clutch pack and glaze the frictions in reverse and low gears.

This can happen before the vehicle is road-tested, and cannot be fixed without removing the glaze from the friction plates.

Intermediate clutch pack clearance can be checked with a tool, or through a small hole in the case after the front pump has been installed. (See Figure)

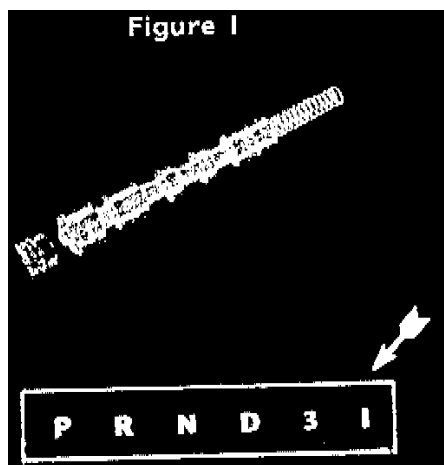
Some AOD's may not have manual low because of the valve body layout. If the shift selector reads P-R-N-OD-3-1, the transmission should have a one-piece 1-2 shift valve in it (See Figure 1). This unit should give you manual low.

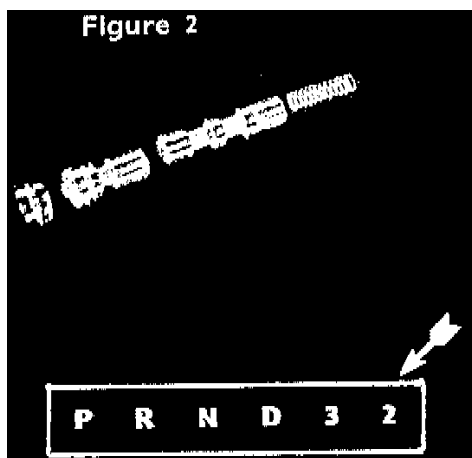
If the selector reads P-R-N-OD-3-2, the unit should have a 1-2 shift valve in it (See Figure 2). This transmission will not have manual low. The transmissions with no manual low were usually found in police cars, but may also be found in other vehicles.

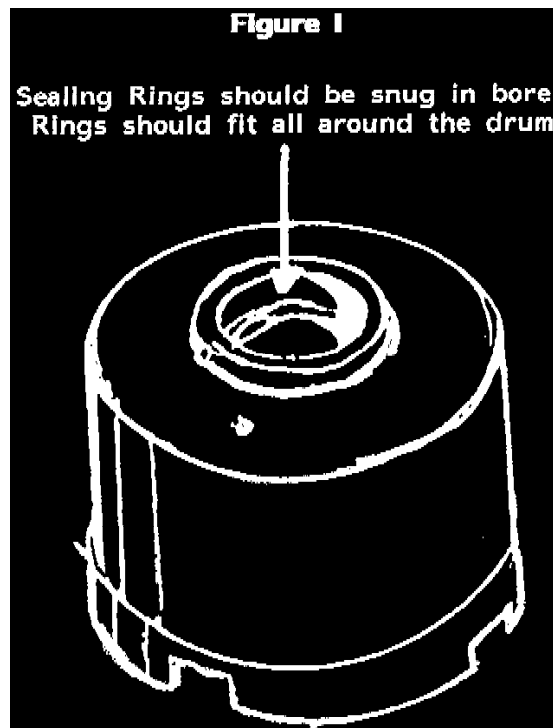
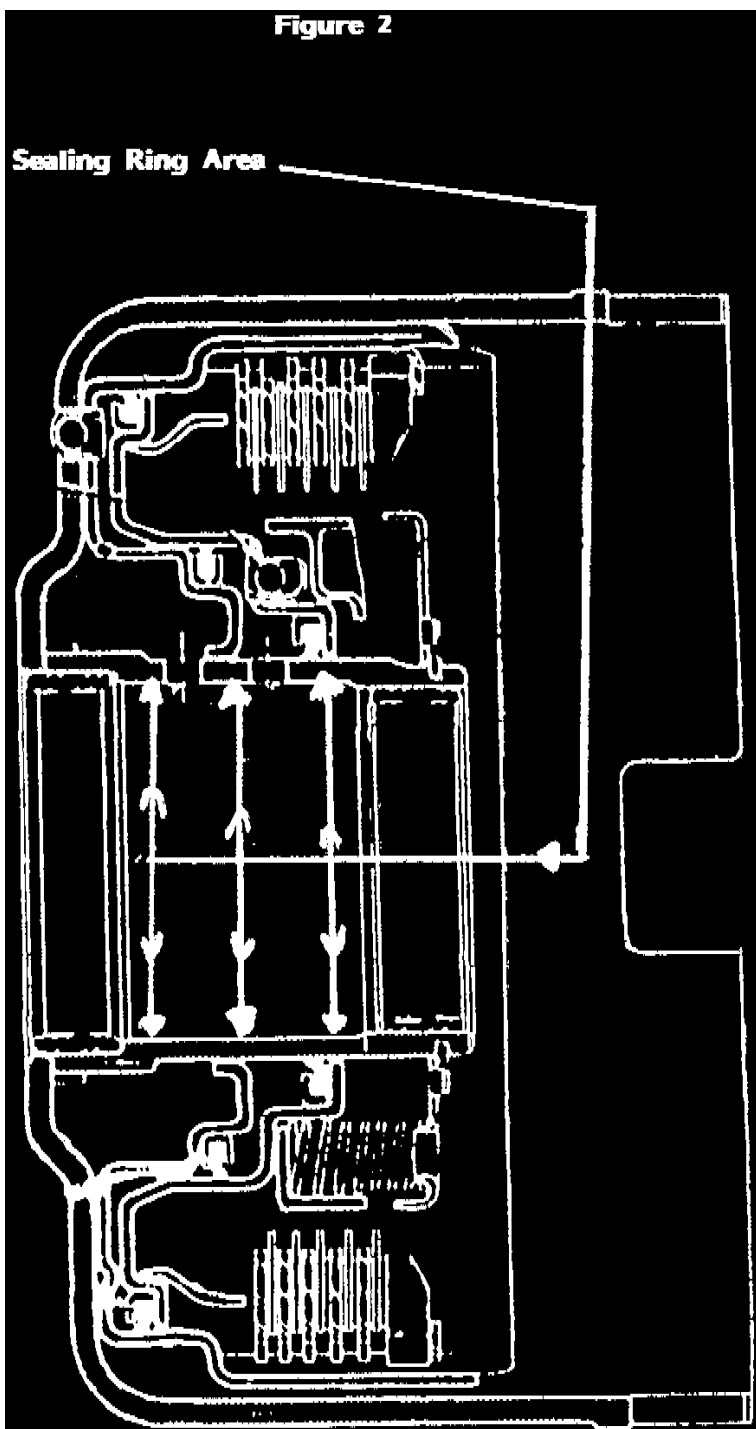
POSSIBLE SOLUTION: Sealing rings could be under-size.

2. Place ring in bore of drum where they will be running. (See Figures 1 & 2)
3. Sealing rings should be snug in bore; rings should fit all around the drum. (drum could be out-of-round)
4. Air check all drums. (Use 30 PSI air pressure only.) If air escapes you have leaks -- better find now, than later. This represents lost clutch pressure, and could result in soft application and burned friction material.
5. Following these steps will help you save money, plus help you build better units.

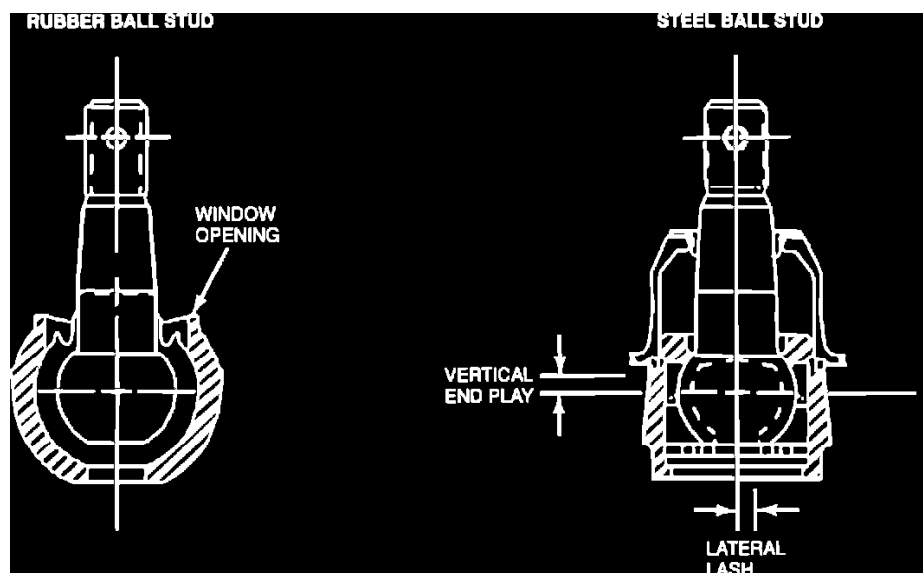
**Figure 1**

- a. For rubber ball socket (RBS) joints, see if the ball stud makes contact with the window opening in the socket bowl while on the truck, Figure 1. If contact is made with the window opening, replace it with a greaseable steel joint.
- b. For steel (greaseable) joints, measure the lateral (side to side) lash in the joint, Figure 1.
  1. If the lash exceeds .060" (1.59 mm), replace the joint.
  2. With the truck on a hoist, check the steel (greaseable) joints for vertical (up and down) end play by pushing and pulling on the joint, Figure 1. If the end play exceeds .090" (2.38 mm), replace the joint.

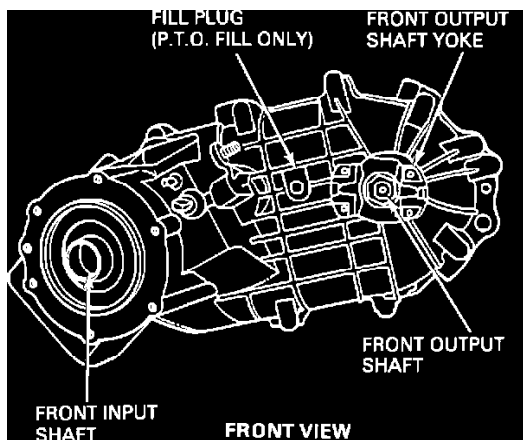
**FIGURE 1**

**ISSUE:** Warner 356 transfer case assemblies with "Dana" P.T.O. units require 4.8 quarts more oil (Dexron II ATF) than transfer cases without P.T.O's. Transfer cases equipped with P.T.O's that are operated under a continuous load in excess of 11 minutes may exhibit failures due to a low fill.

**NOTE:** SOME TRANSFER CASES HAVE A FILL PLUG LABELED "FOR P.T.O. FILL ONLY" ON THE FRONT OF THE CASE, FIGURE 1.

1. Locate the fill plug on the front of the transfer case labeled "FOR P.T.O. FILL ONLY", Figure 1. Fill oil to the level of this fill hole. If this fill hole does not exist, proceed to Step 2.

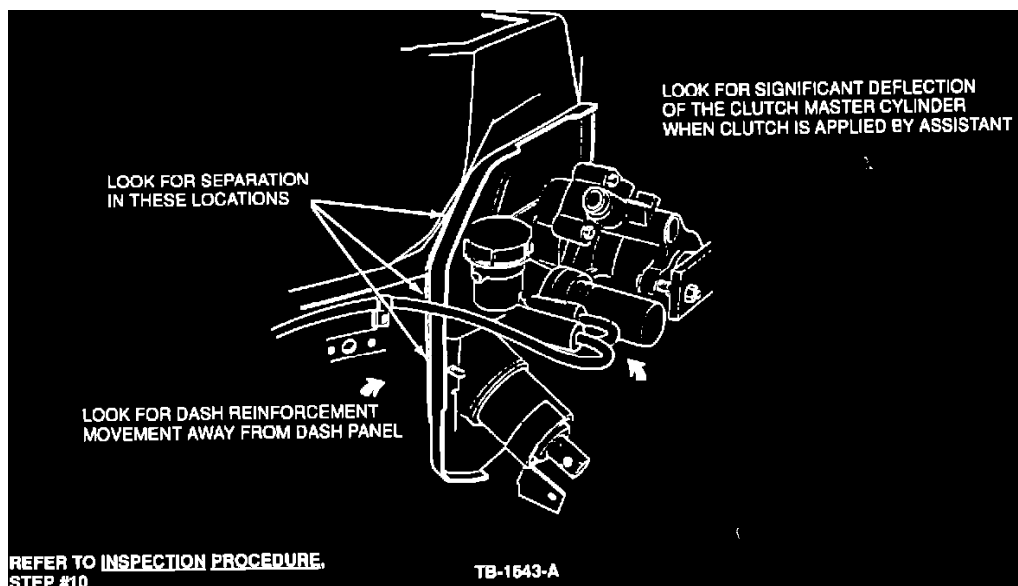
Figure 3

- c. Look for the dash reinforcement moving away from the dash, Figure 3.
  - d. On 1987 and earlier models, look down inside the cowl cover at the cowl where it is attached to the dash reinforcement. Check for pulled spot welds.
11. If there is significant movement of the dash or clutch master cylinder, proceed as follows:
- a. Remove the steering column and its dash toe plate and seal. Refer to the appropriate Light Truck Shop Manual, Section 13-07 for service details.
  - b. Inspect the dash inside the cab and look for:
    - ^ Pulled spotwelds and cracked or torn sheet metal.
    - ^ Cracks in the brake and clutch pedal support

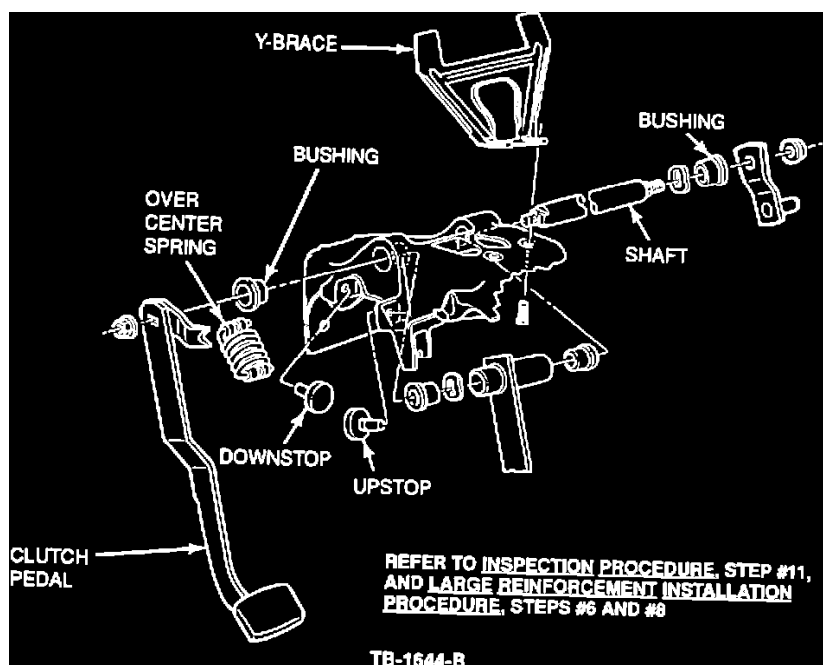
Figure 4

- ^ Missing Y-brace fasteners and a broken or detached Y-brace, Figure 4.
