**Transmission and Drivetrain: Technical Service Bulletins**Technical Service Bulletin # **B82871201**Date: **871201****Campaign - Weight Certification Label Are Overstated**

TSB # B821287 December, 1987

SUBJECT: Owner Notification Program B82 - Installation of a Safety Compliance Certification Label on Certain 1988 F250 4x2 HD and F350 4x4 Vehicles Equipped With Optional Engine

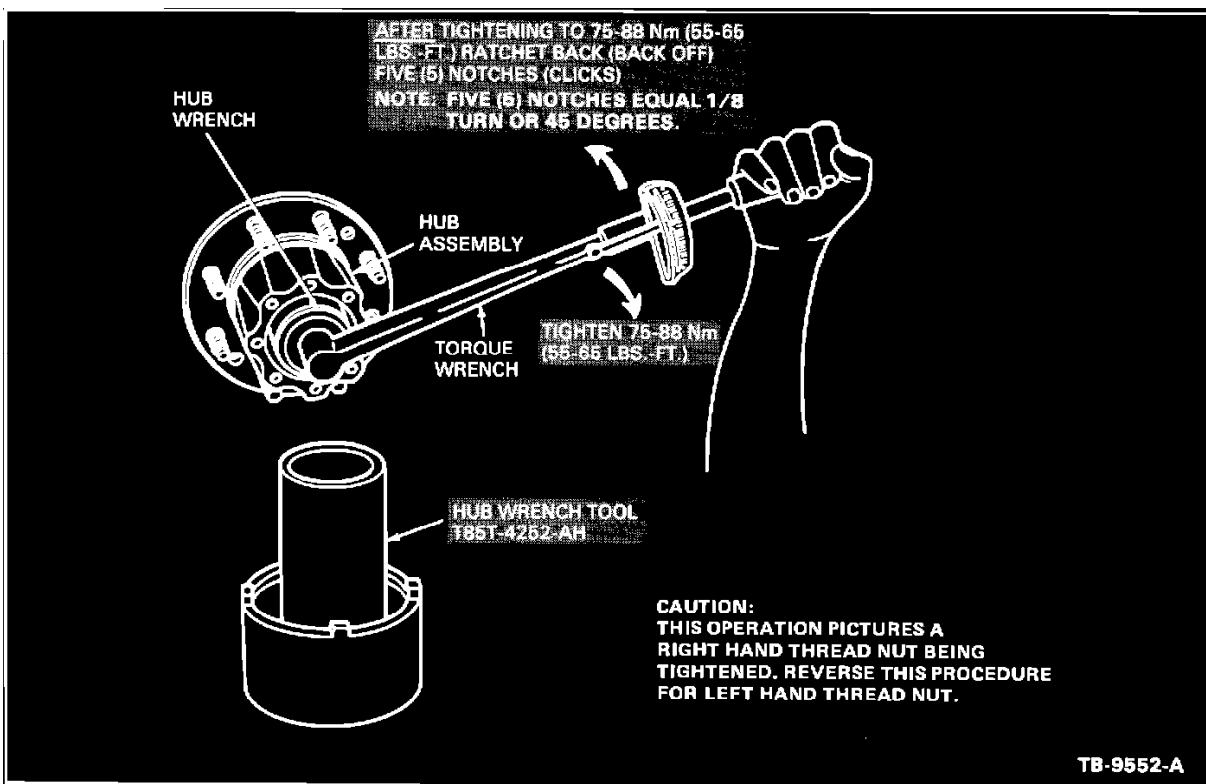
FIGURE 13

ISSUE: The hub removal and installation procedure as published in the 1988 Light Truck Shop Manual, Volume A, Section 15-09-16 is incorrect. The notes and specifications in the illustration on top of the page have been changed.

**ACTION:** If service is required, refer to the corrected illustration in this TSB article, Figure 13. This information should be inserted in your 1988 Light Truck Shop Manual, Volume A, Section 15-09-16.

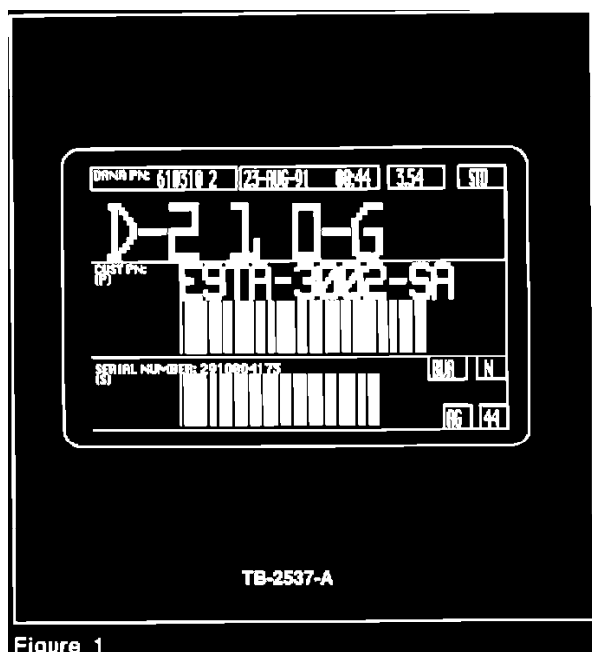
Figure 1

The 1992 model year axles use a glue-on label that replaces all three of the prior identification markings, Figure 1. The new label is on the rear face of the right hand arm (tube).

**ACTION:** Since this glue-on label, Figure 1, is the only identification, be sure that the information on the label is recorded in a retrievable place before any service actions are taken which will damage/destroy or remove the label.

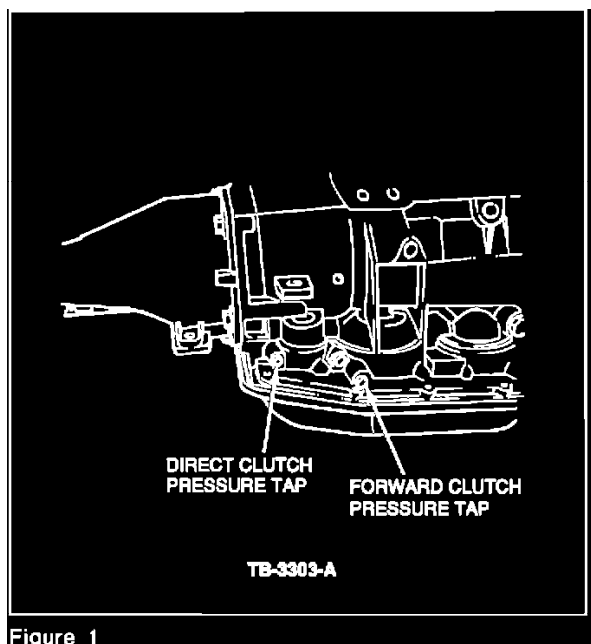
Figure 1

The direct clutch pressure test outlined below will diagnose a low pressure condition or leakage in the direct clutch circuit. A difference of 15 psi or more between direct clutch pressure and line pressure (read at the forward clutch pressure tap) will prevent a 3-4 upshift.

1. Attach 0-300 psi (0-2068 kPa) pressure gauges to the forward clutch and to the direct clutch pressure tap, Figure 1.
  - a. Gauge accuracy must be capable of distinguishing a 15 psi (110 kPa) difference (if this test is done in conjunction with a control pressure test, pressure gauges will be attached to all pressure taps).
  - b. Connect sufficient flexible hose to be able to read the gauges inside the vehicle.

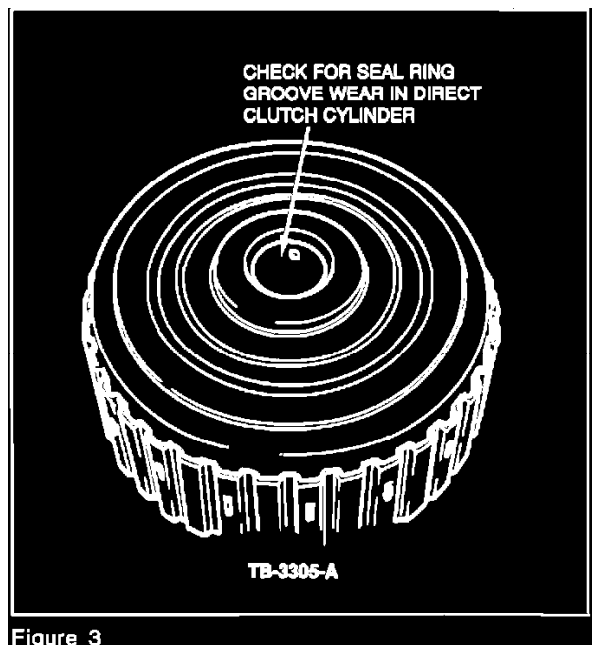
Figure 3

8. Check the direct clutch cylinder for groove marks on the inner ID of the drum, Figure 3.
  - a. Groove marks indicate that the small cast iron rings are turning with the output shaft and grooving the cylinder.
  - b. Groove marks may also be caused by contamination or burrs in the output shaft seal ring grooves, causing the seal rings to turn with the output shaft.
  - c. Check the seal ring grooves carefully. replace the output shaft, seal rings and/or cylinder as required, and/or replace the case if the output shaft seal bore is grooved.

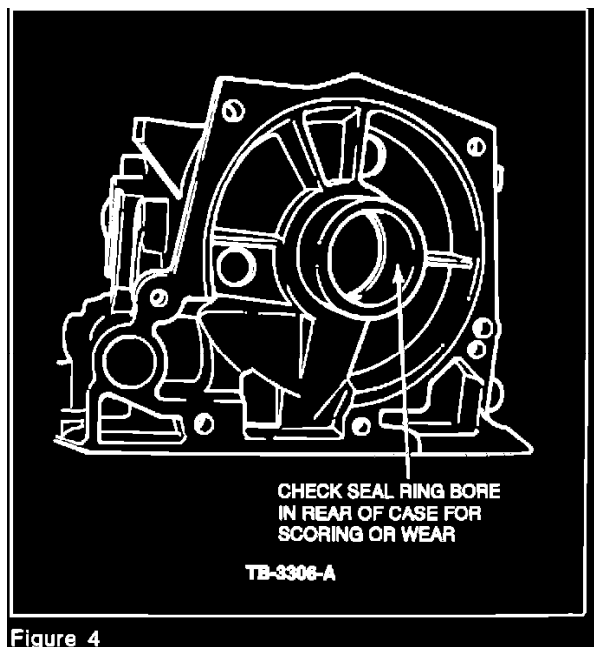
Figure 4

6. Check the seal ring bore at the rear of the case for scoring. Light scoring is permissible, but deep grooving indicates case wear. Replace the case if deep grooving is found, Figure 4.

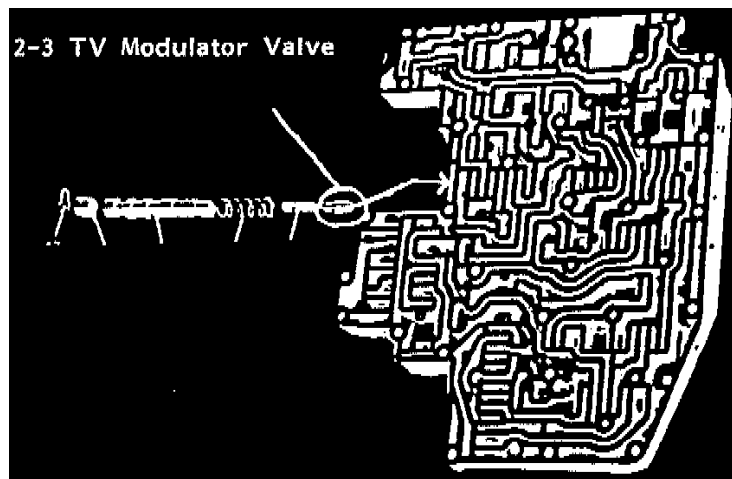
Too sensitive 3-2, or no 3-2 part throttle downshift.

May be a sticky 2-3 TV modulator valve. If it sticks closed, it can cause a no 3-2 part throttle downshift. If valve sticks open, it can cause a too sensitive 3-2 downshift.

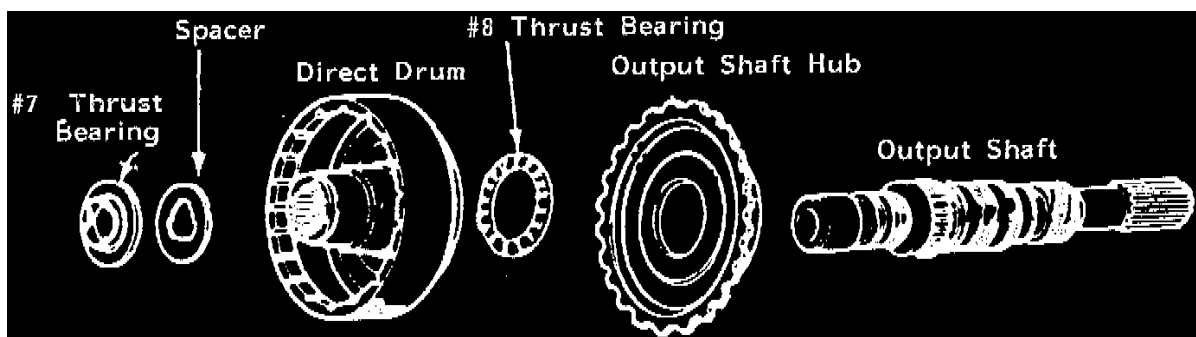
High Pitched Noise in all Ranges. The noise becomes louder as the engine RPM increases.

Checking for location of noise with stethoscope will help verify if the noise is coming from the front or the rear of the transmission. It may be a bad bearing on either side of the direct drum (# 7 and # 8 Thrust Bearings).

When checking the thrust bearings on the front and rear of the direct drum, be sure the output shaft hub is smooth where the # 8 thrust bearing rides against it.

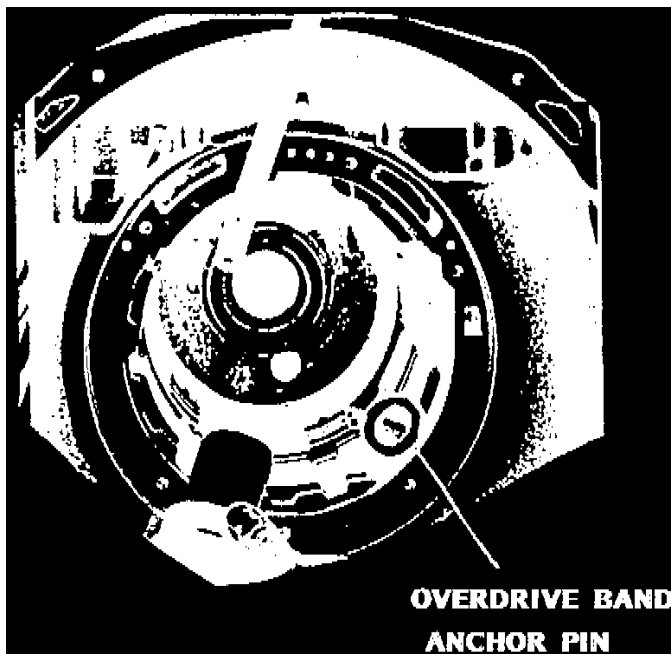
If the problem exists no matter which selective thrust washer is used, it may be the overdrive band anchor pin binding the overdrive band against the reverse clutch drum.

During assembly, it may not appear that the band is binding against the reverse clutch drum. When the pump is installed, it may move the reverse clutch drum to center it, and that's when the reverse clutch drum and the overdrive band will bind.

Knock the overdrive anchor pin outward until it is no longer binding the overdrive band against the reverse clutch drum. Be careful; do not tap the anchor pin out too far! Put sealant on the anchor pin where it extends to the outside of the case.

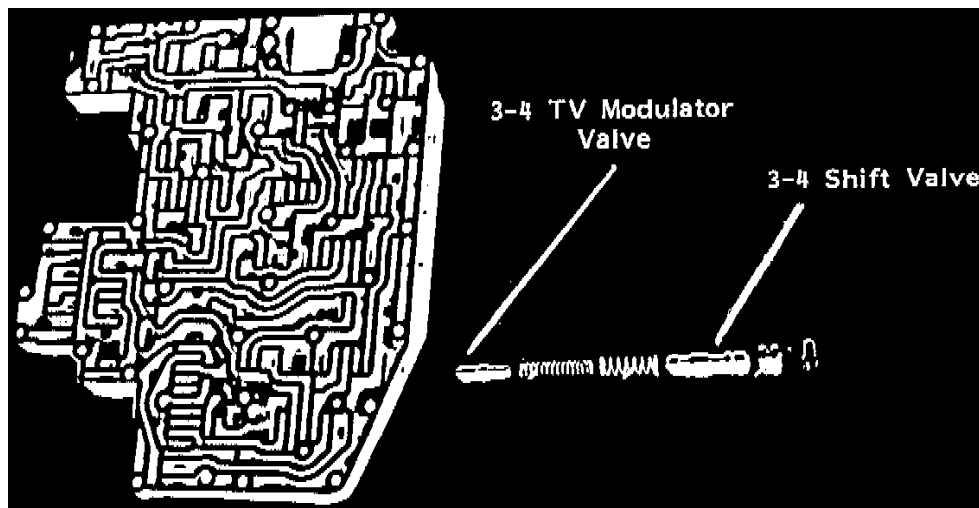
If the 3-4 shift valve is not upshifting, the possible problems are reduced considerably. These possible problems include: the 3-4 shift valve or the 3-4 modulator valve sticking, or governor oil is not rising high enough to shift the valve.

Remove the oil pan, extension housing and the governor. Air check the valve body through the governor feed hole, and try to "feel" the 3-4 shift valve for free movement while looking for excessive leakage. A common source for excessive governor leakage is the round aluminum plugs in the valve body, valve body gaskets, or where the governor support mates to output shaft.

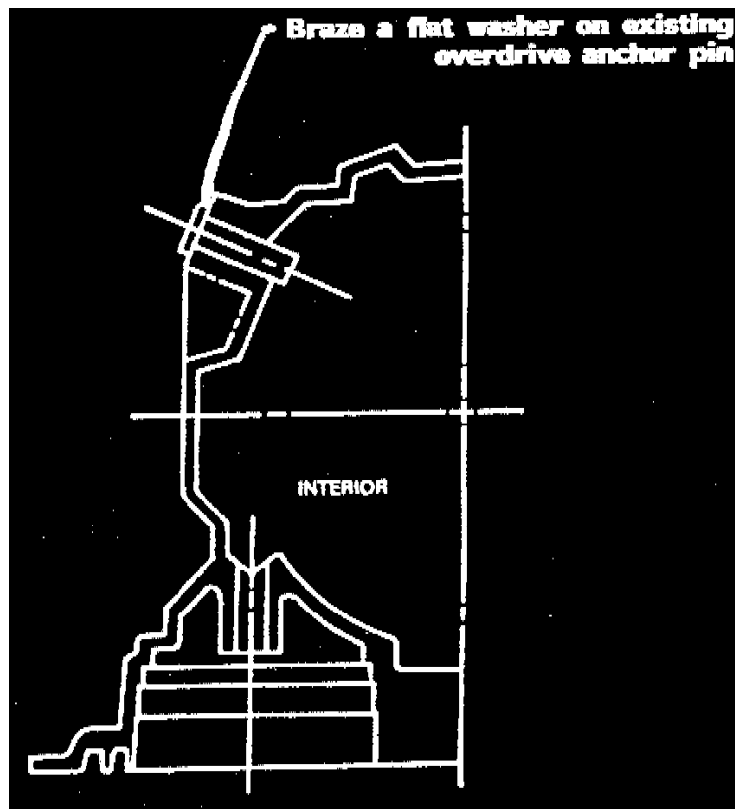
CAUSE: May be mis-positioned overdrive anchor pin

Instead of purchasing a new style anchor pin, braze a flat washer on the existing pin.

The anchor pin should be positioned so the outside flat surface is flush with the flat case surface.

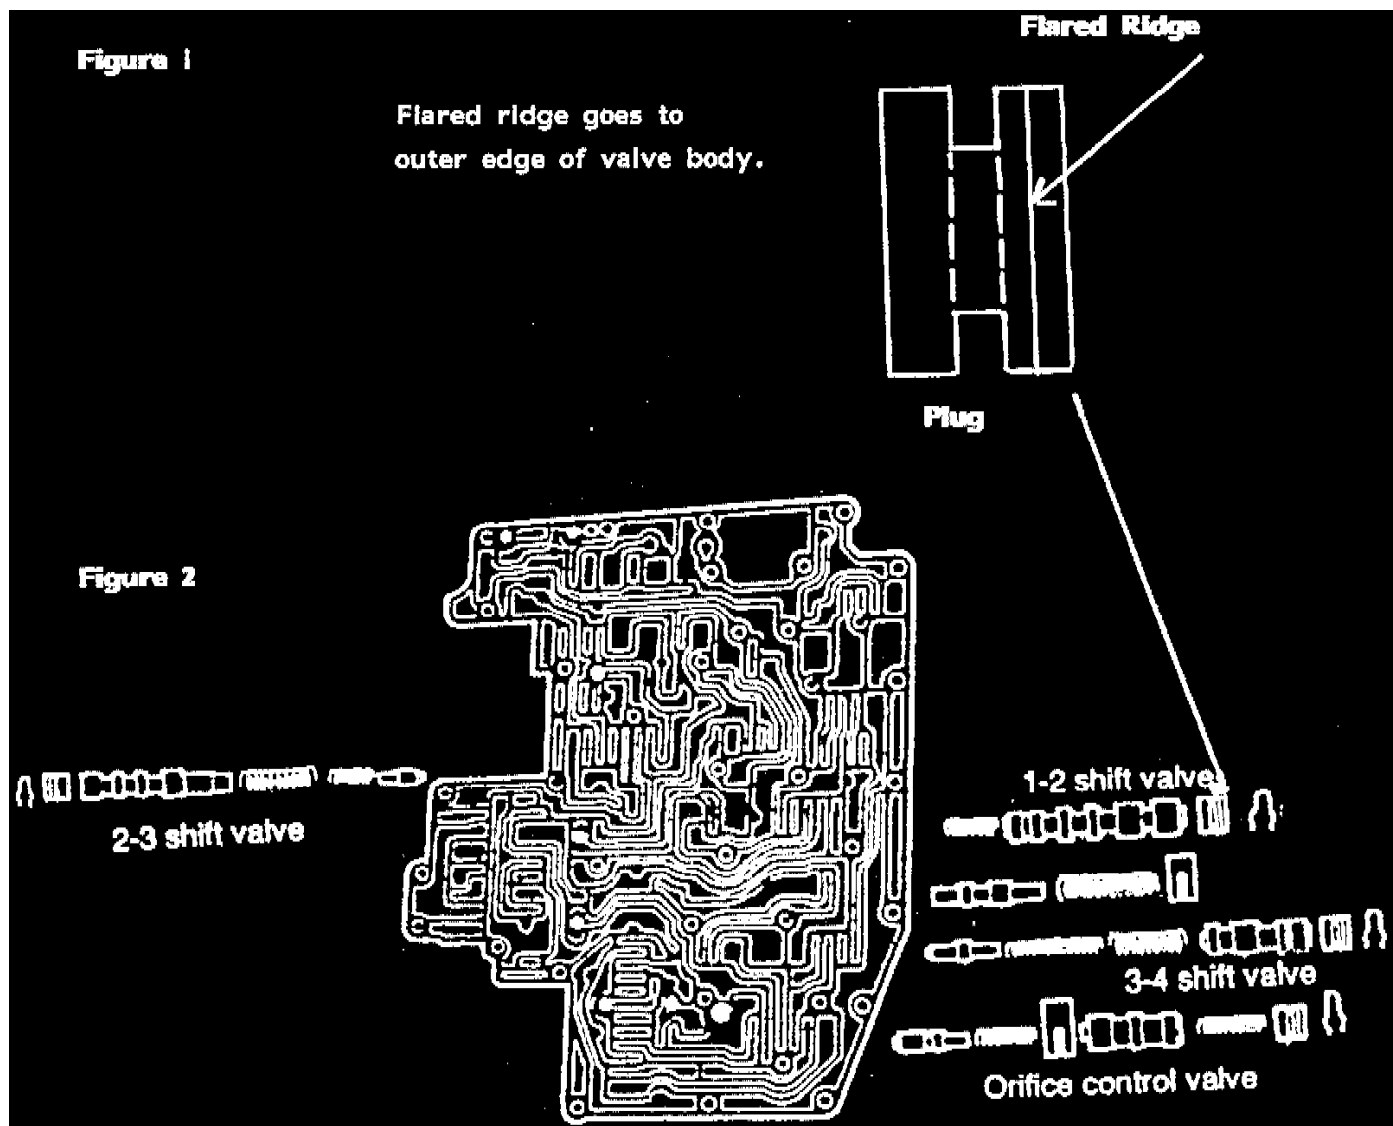
Governor pressure is sealed in the valve body by aluminum plugs held in by a keeper at the edge of the valve body.

Be sure to check the plug keeper for wear.

A worn keeper will allow the plug to move back and forth, causing plug to lose its snug fit.

An easy way to seal these plugs is with a small tubing cutter. By running a small ridge around the outer diameter of the plug, flare the metal just enough to obtain a snug fit when installed (See Figure 1).

The plugs that should be sealed are for the 1-2, 2-3 and 3-4 shift valve and orifice control valve (Figure 2).

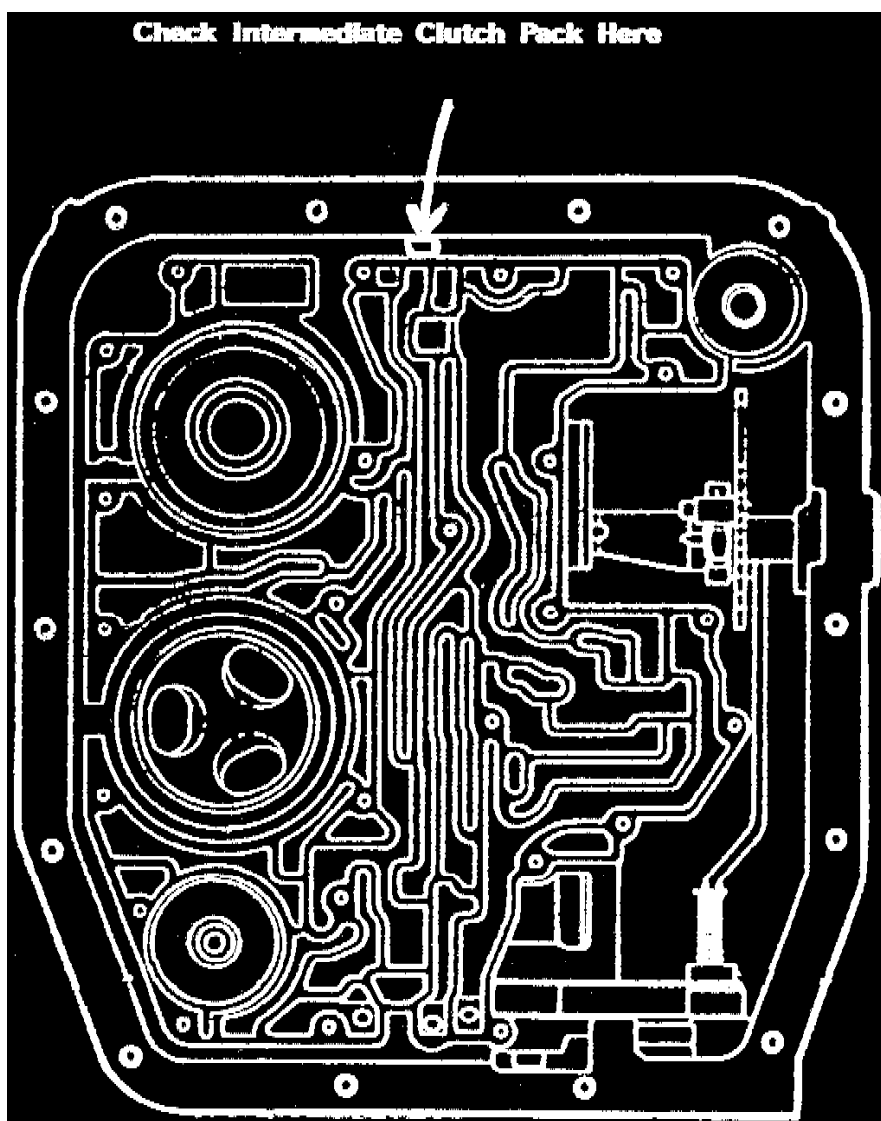
May be caused by improper intermediate clutch pack clearance

If intermediate clutch pack clearance is not checked on AOD transmissions, the intermediate return spring assembly in the pump may drag the clutch pack and glaze the frictions in reverse and low gears.

This can happen before the vehicle is road-tested, and cannot be fixed without removing the glaze from the friction plates.

Intermediate clutch pack clearance can be checked with a tool, or through a small hole in the case after the front pump has been installed. (See Figure)

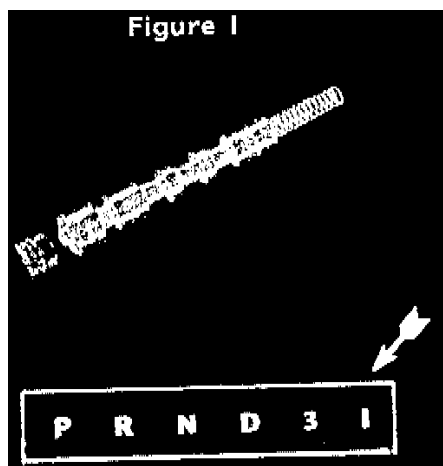
Some AOD's may not have manual low because of the valve body layout. If the shift selector reads P-R-N-OD-3-1, the transmission should have a one-piece 1-2 shift valve in it (See Figure 1). This unit should give you manual low.

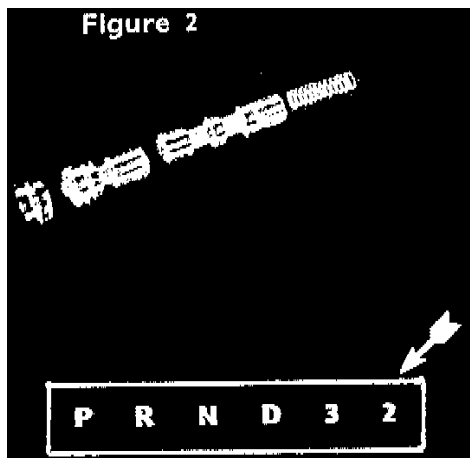
If the selector reads P-R-N-OD-3-2, the unit should have a 1-2 shift valve in it (See Figure 2). This transmission will not have manual low. The transmissions with no manual low were usually found in police cars, but may also be found in other vehicles.

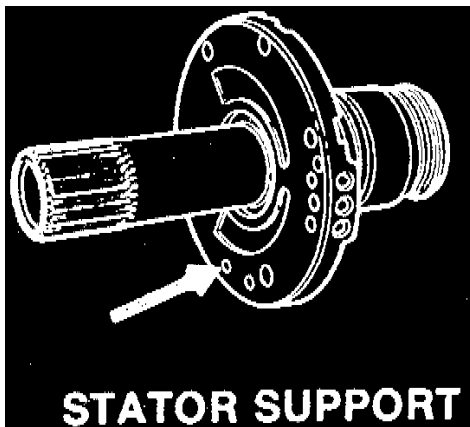
PROBLEM: Rear planet failure, due to lack of lubrication

3. Cooler checkball in pump cover is restricted. (See figure) Debris from the converter flows through the passage and can lodge next to the ball, which severely restricts lube flow around the ball. The planets need all of the lube flow available, and the pinion shafts and bearings will "blue" and/or seize if any lube flow is lost.

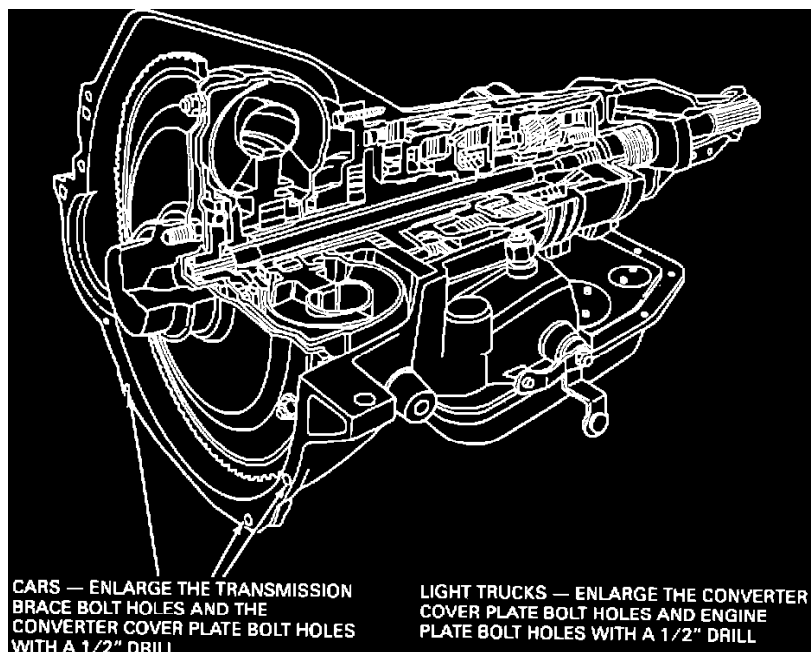
FIGURE 1

ISSUE: The 1989 model year "AOD" transmission case threads are different from prior model year cases. Prior model year transmission cases use a 5/16"-18 thread. 1989 model year transmission cases use a M10-1.5 thread. The larger M10-1.5 bolts will not pass through the prior model year converter plate, transmission brace or engine cover plate.

ACTION: If a transmission case replacement is required on a past model vehicle, the bolt holes for the car's transmission brace and converter cover plate will need to be enlarged with a 1/2" drill. On light trucks, enlarge the converter cover plate and engine cover plate with a 1/2" drill. Refer to Figure 1 for the bolt hole locations.

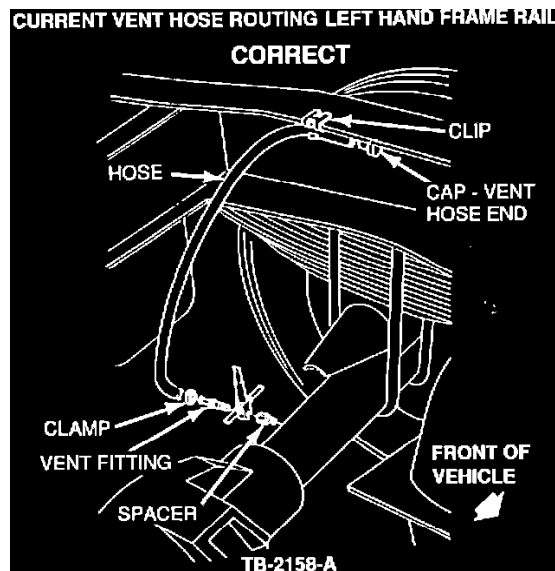
Figure 1

ISSUE: Rerouting of the rear axle vent hose provides better protection against water entering the axle through the vent hose.

**ACTION:** Check the location of the rear axle vent hose routing which is identical for F-150/250/350 and Bronco Light Trucks. The rear axle vent hoses are mounted on the left hand frame rail (driver's side). This location provides better protection against water entering the axle through the vent hose. Refer to Figure 1; Correct Vent Hose Routing. Previously, vehicles with aft fuel tanks were equipped with the vent hose mounted on the aft axle cross member. This routing has been discontinued. Refer to Figure 2; Incorrect Vent Hose Routing.

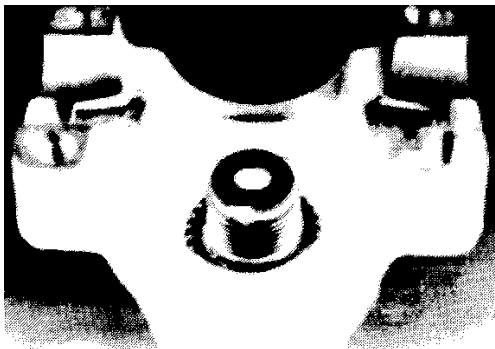
**Figure 1**

**ISSUE:** A "bumping/clunking" noise or a "clicking" sound on torque reversal or transmission lubricant leakage may be caused by a loose output flange retaining nut.

**ACTION:** Install a new output flange retaining nut. Refer to the following procedure for service details.

**CAUTION:** DO NOT REUSE THE OUTPUT FLANGE RETAINING NUT AFTER ANY SERVICING OF THE TRANSMISSION. ALWAYS REPLACE IT WITH A NEW ONE.
